# City of Bainbridge Island & Bainbridge Island Fire Department

Facilities Assessment

March 05, 2014

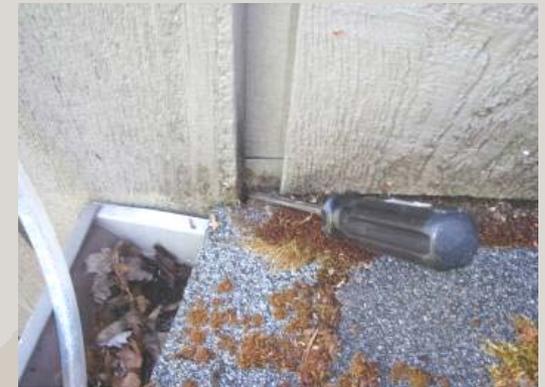
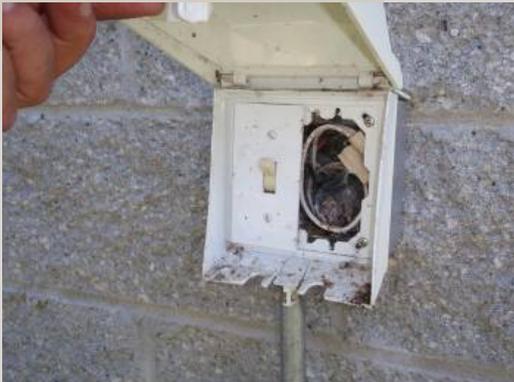
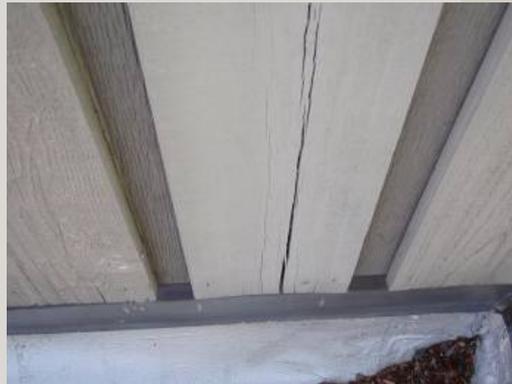
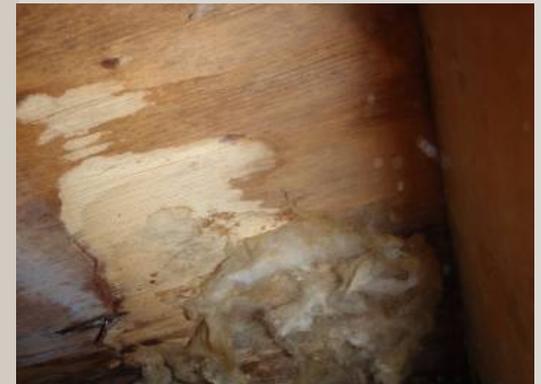
## Energy Code Deficiencies

- Flashing missing in areas – wood siding damaged
- Improper placement of moisture barrier
- Moisture damaged insulation and mold growth in attic
- Make-up air louver not functioning properly
- Inadequate insulation – does not meet energy code.

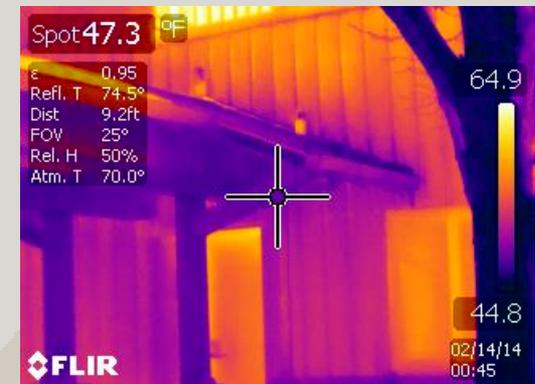
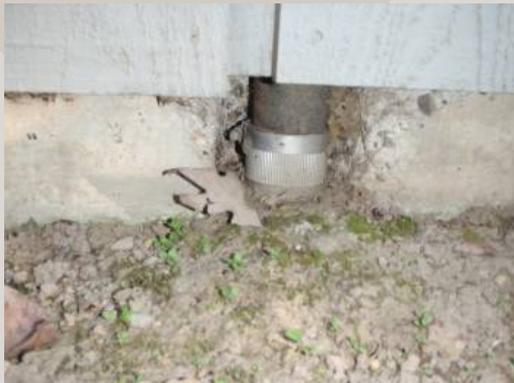
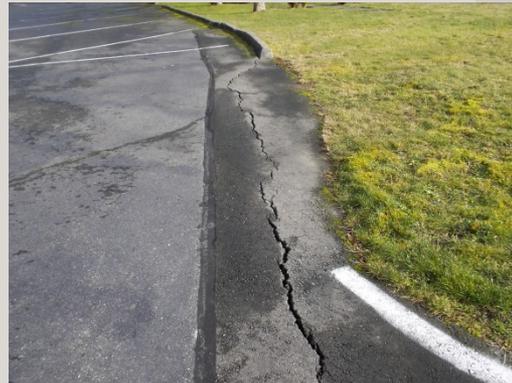
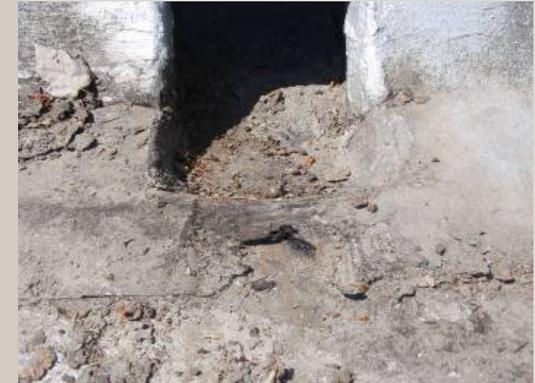
## Building Systems at End of Useful Life

- Exterior windows have lost thermal seals
- Corrosion of roof drains.
- Existing storm water drainage system is dysfunctional – standing water around building
- Existing exterior walls are deteriorating – water damage and rot
- Failing asphalt and hardscape surfaces (cracking and upheaving)

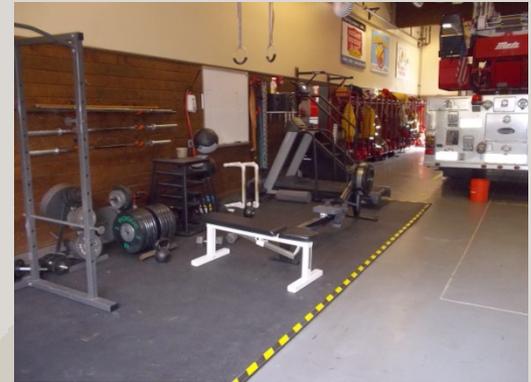
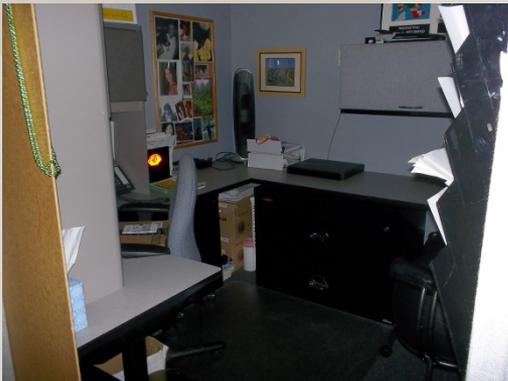
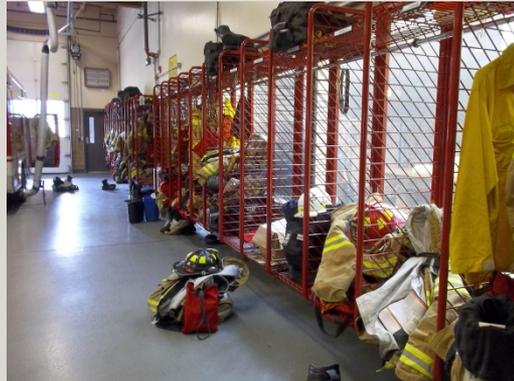
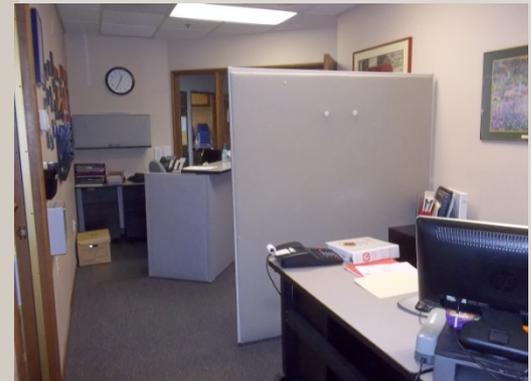
## Support Spaces and Systems Deficiencies

- Inadequate space allocation
  - No dedicated fitness room
  - Insufficient storage
  - Turn out gear not protected from UV exposure or contaminants
  - Not enough office spaces

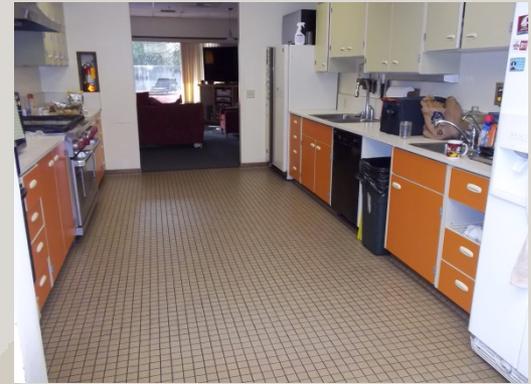
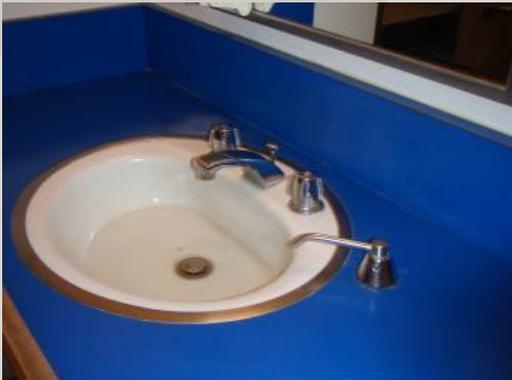
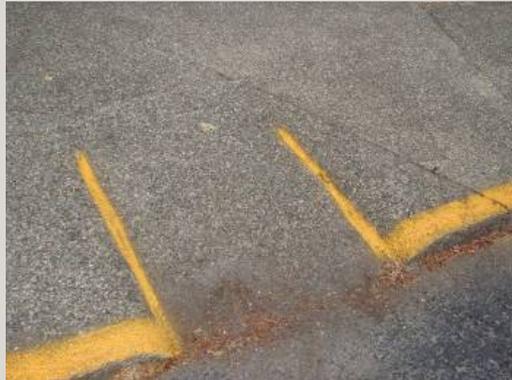
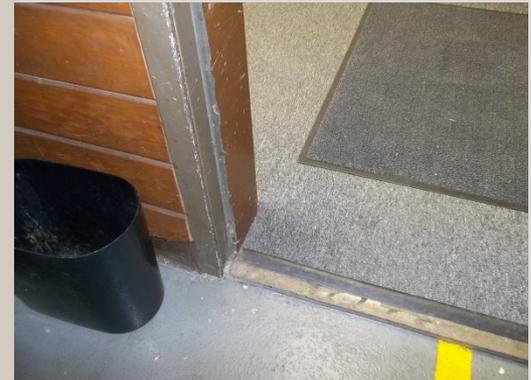
## ADA Deficiencies

- Non-ADA compliant ramp transitions
- Door hardware not ADA compliant
- Non-ADA compliant toilet rooms and kitchen
- Non-ADA compliant door thresholds and floor transitions

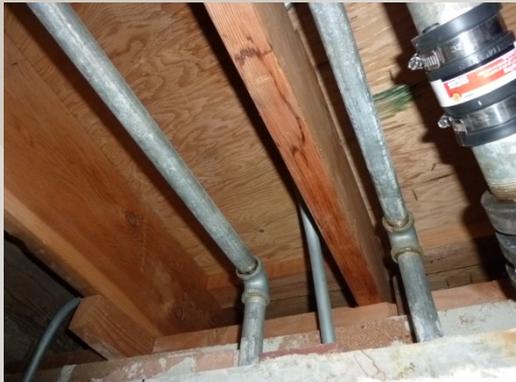
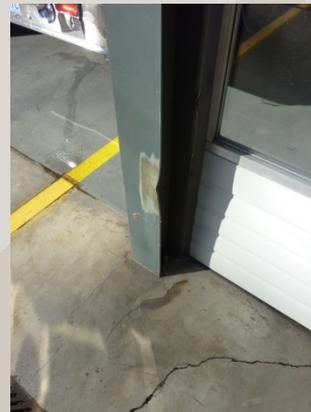
## Structural Deficiencies

- Unreinforced masonry building
- Inadequate seismic anchorage between roof and masonry walls
- No continuous cross ties between diaphragm chords
- Wood ledger/top plate connections induces cross grain bending
- Damaged steel columns and slab at apparatus bay area
- Water damaged structural beams

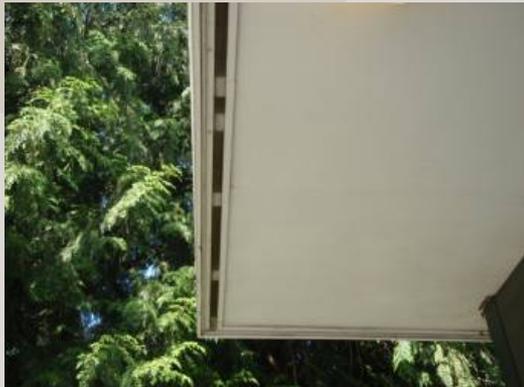
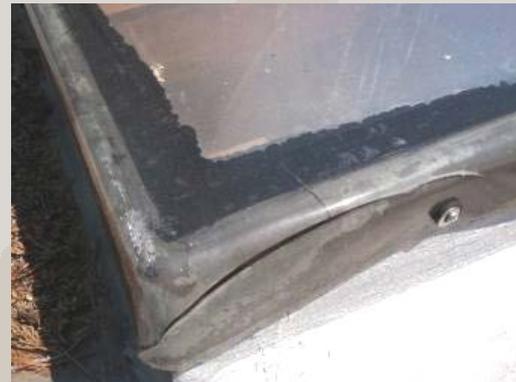
## Deficiencies

- Exposed electrical outlets/junction boxes
- Roof not properly ventilated
- Roof drains not properly installed
- Leaking skylights

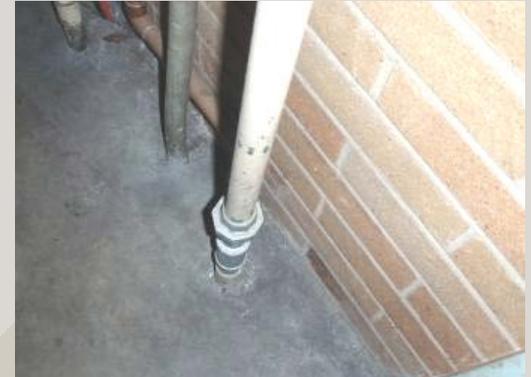
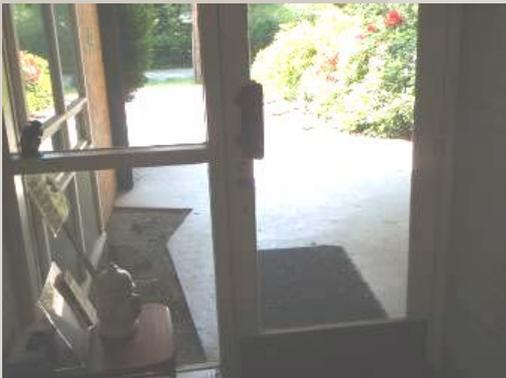
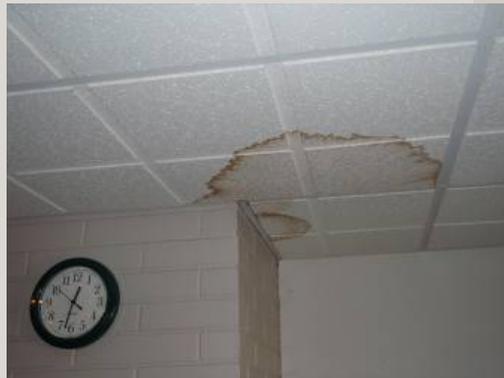
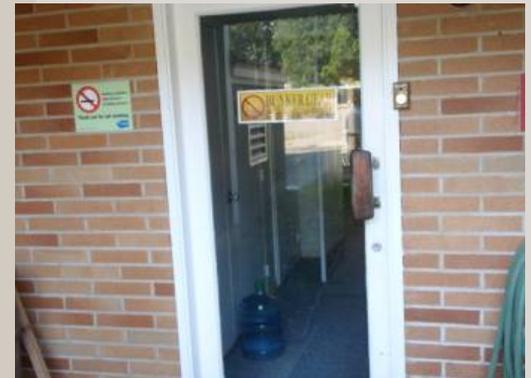
## Energy Code Deficiencies

- Does not meet energy code requirements
- Single pane windows and un-insulated doors
- Inadequate HVAC Systems – oil fired furnace
- Un-insulated walls and piping
- Water supply lines are galvanized piping

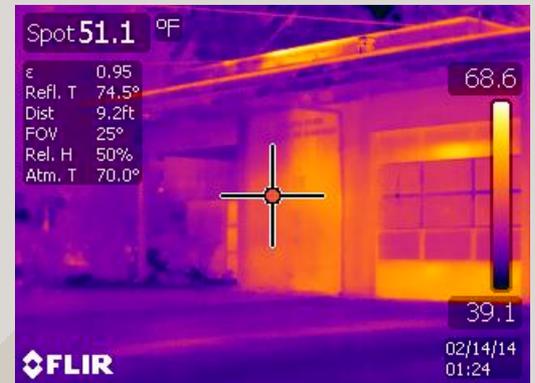
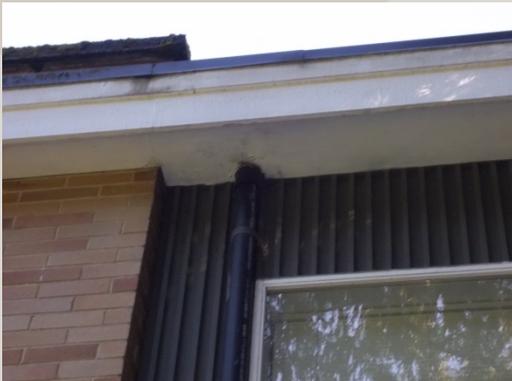
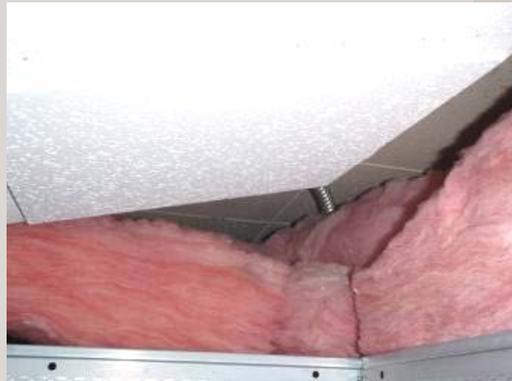
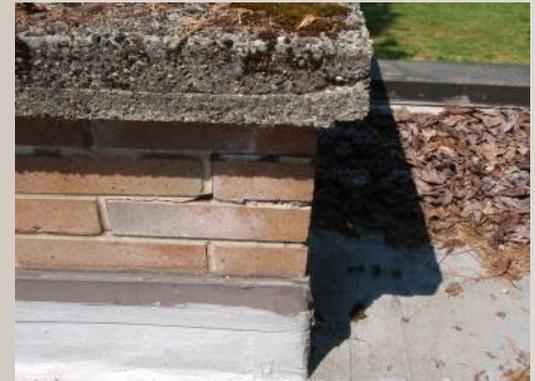
## Building Systems at End of Useful Life

- Brick needs to be re-pointed and sealed
- Damaged concrete slab
- Water tank maintenance required
- Asbestos identified in ceiling tiles

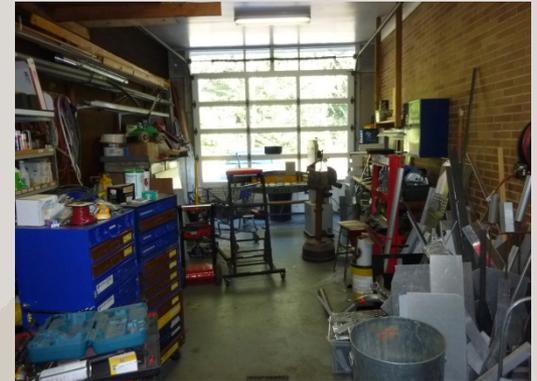
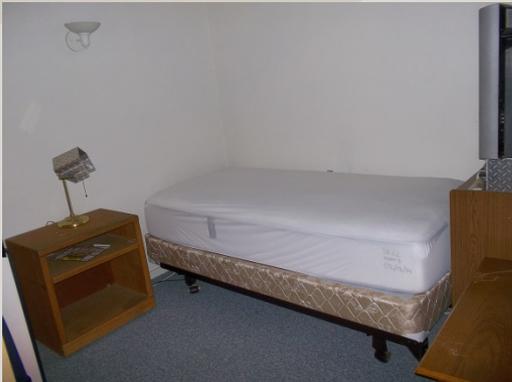
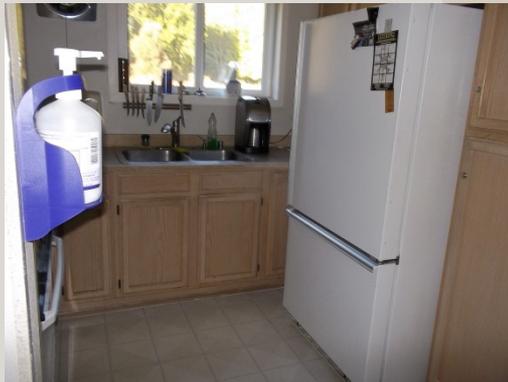
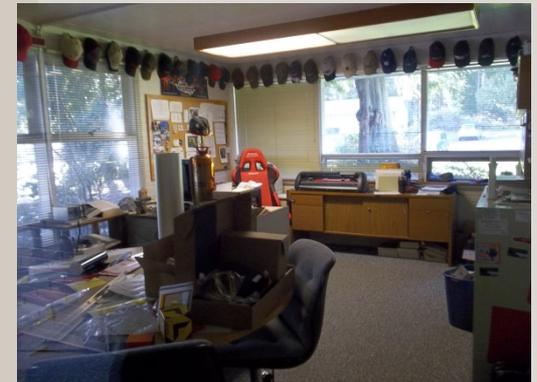
## Support Spaces and Systems Deficiencies

- No dedicated fitness room
- Offices and workspaces are too small and not secured
- Kitchen sub-standard
- Bunk rooms sub-standard
- Storage space is inadequate
- Inadequate or obstructed circulation in apparatus bays
- Turnout gear exposed to UV and air contaminants
- Inadequate space for maintenance of rigs

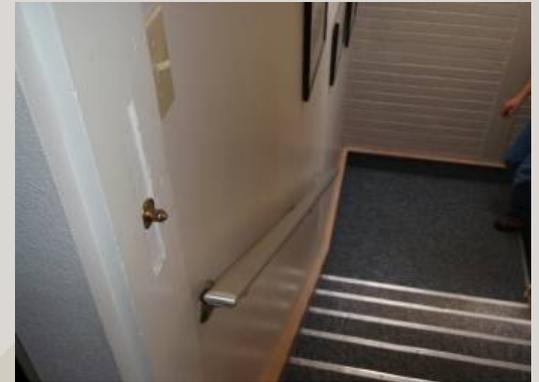
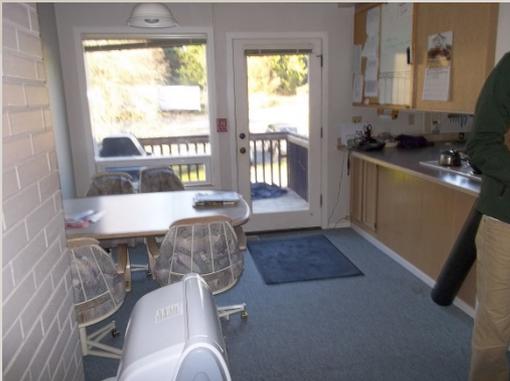
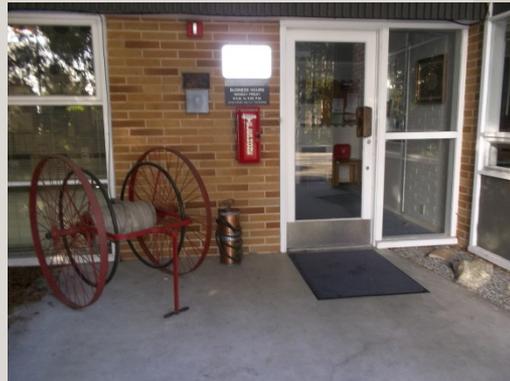
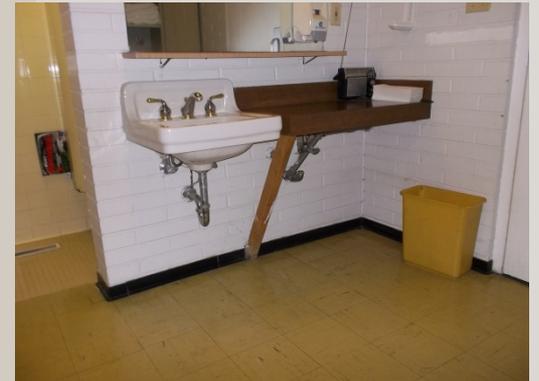
## ADA Deficiencies

- Door hardware not ADA compliant
- Kitchen facilities do not meet accessibility standards
- Restroom facilities do not meet accessibility standards
- Stairs and railings do not meet accessibility standards

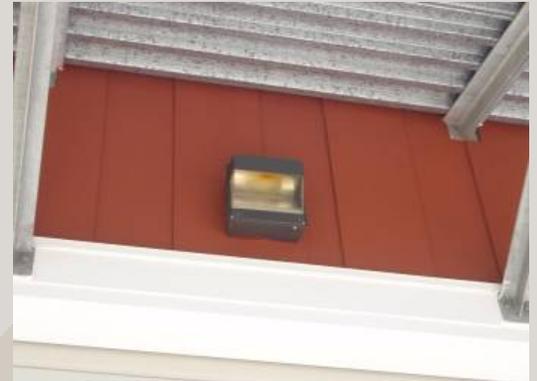
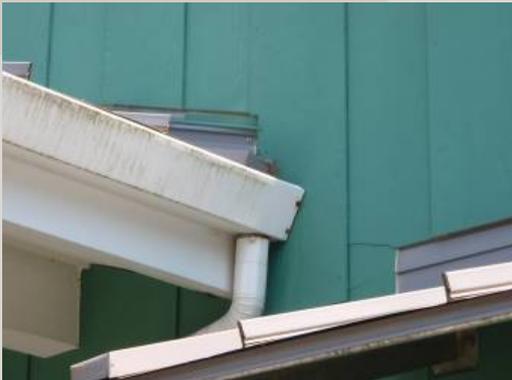
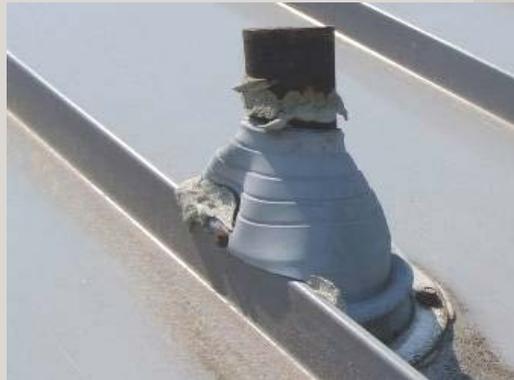
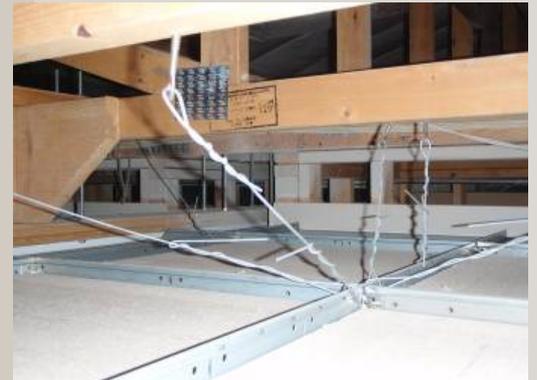
## Fire Station Deficiencies

- Inadequate lighting for security purposes
- Leaking walls and roofs
- Moisture issues in the siding
- Missing bracing for generator and main runners of suspended ceiling system for resisting seismic forces

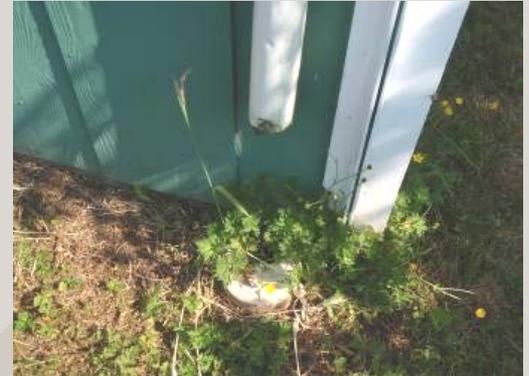
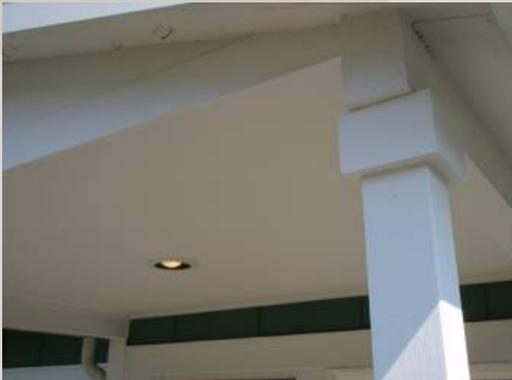
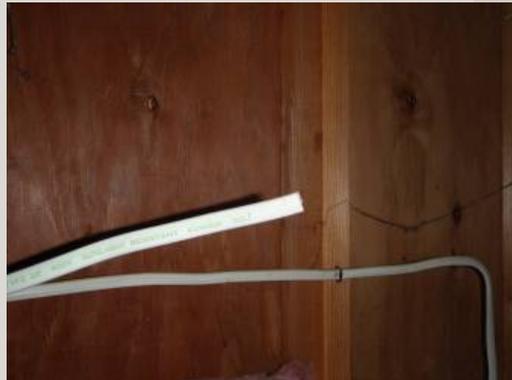
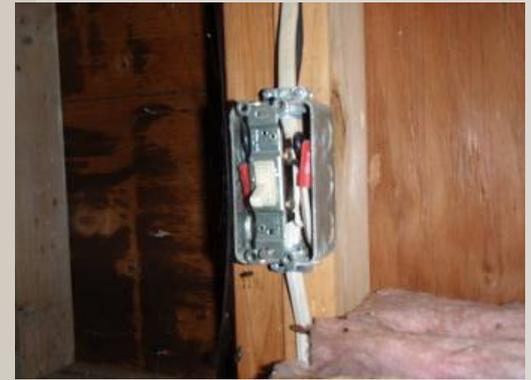
## Residence Deficiencies

- Insufficient insulation
- Inadequate roof ventilation
- New gutters and down spouts needed

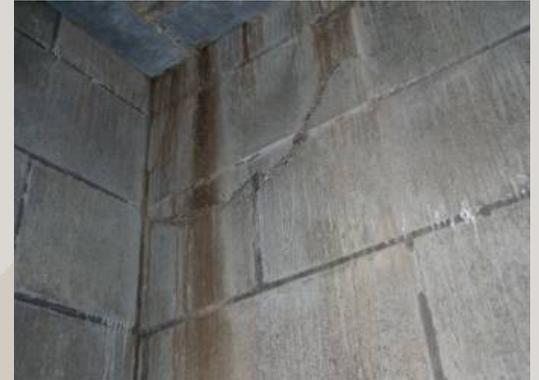
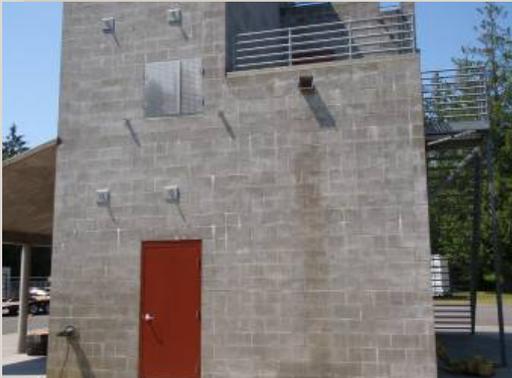
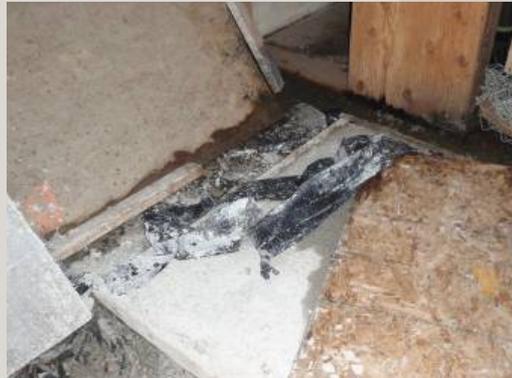
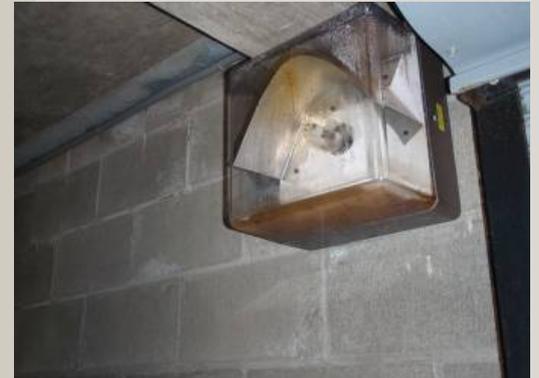
## Tower Deficiencies

- Spalling concrete – needs to be re-sealed
- Clogged roof drains
- Insufficient lighting
- Does not meet NFPA 1402
  - Spalling Concrete
  - No temperature monitoring devices
  - Insufficient size

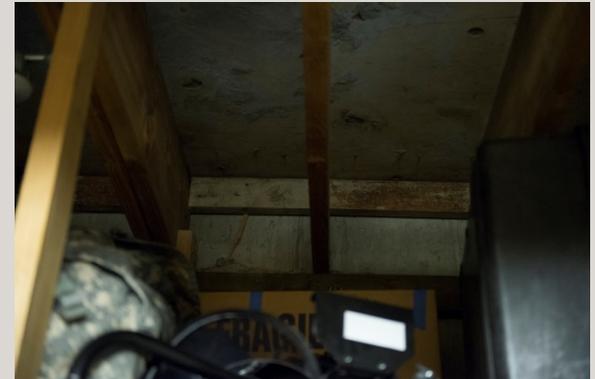
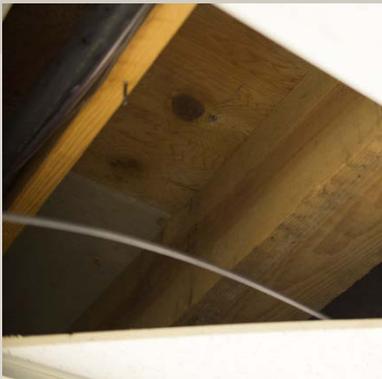
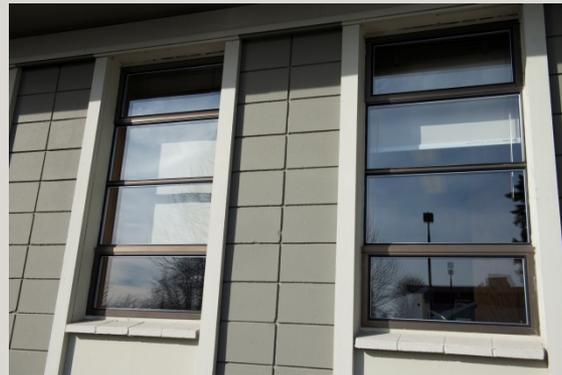
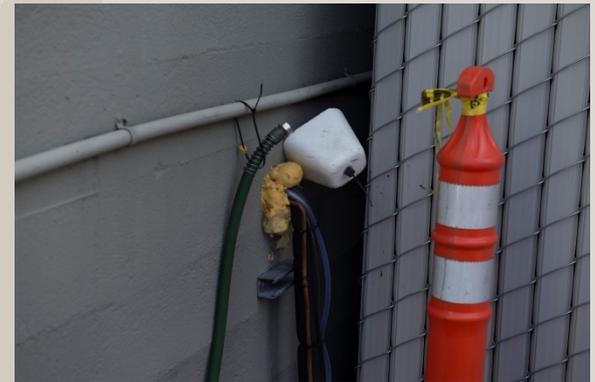
## Structural Deficiencies

- Unreinforced masonry
- Inadequate roof diaphragm to masonry wall connections for shear transfer
- No continuous cross ties between diaphragm chords exist.
- Lack of seismic anchorage between diaphragm and CMU walls.

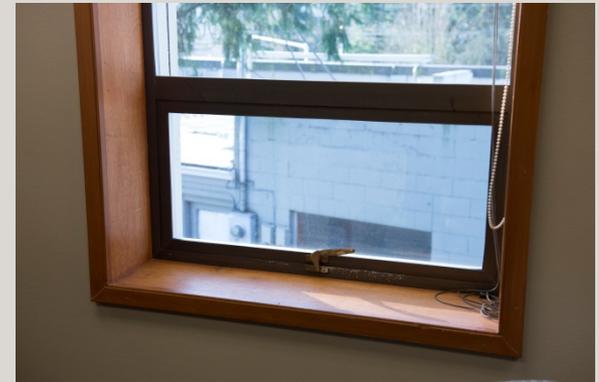
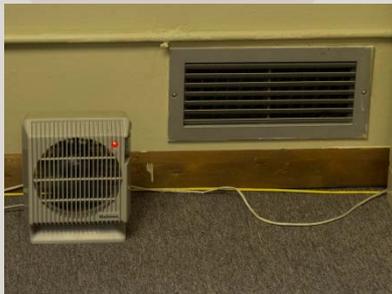
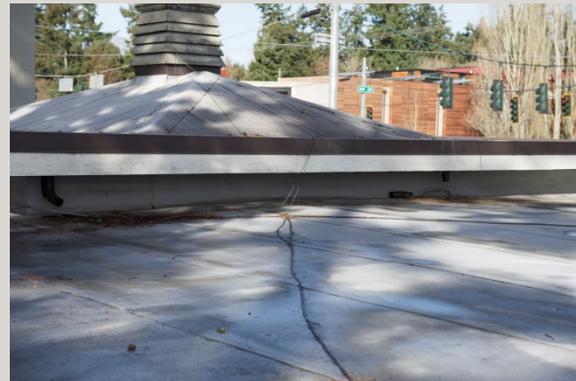
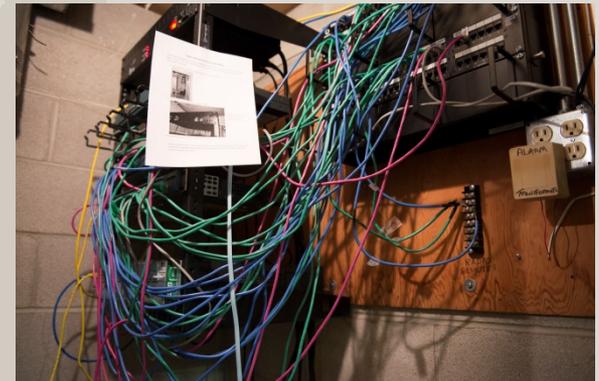
## Building Performance Deficiencies

- Single-pane glazing
- Previous sewage leaks in records room
- Improper installation of utilities
- Conduits and pipe penetrations not sealed properly and exposed to weather
- Inadequate heating – Detective's office does not have heat
- Ferry traffic potentially impacts the ability to respond to incidents

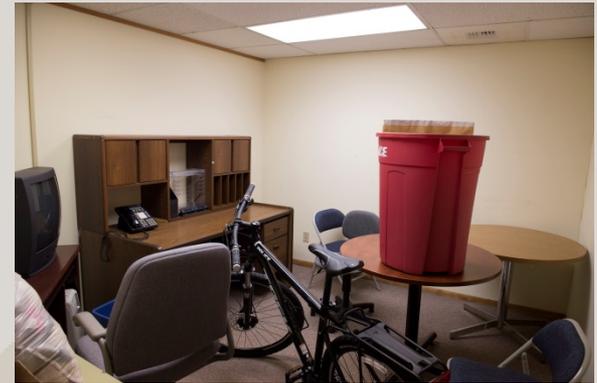
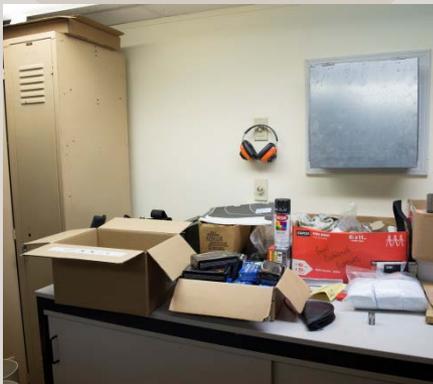
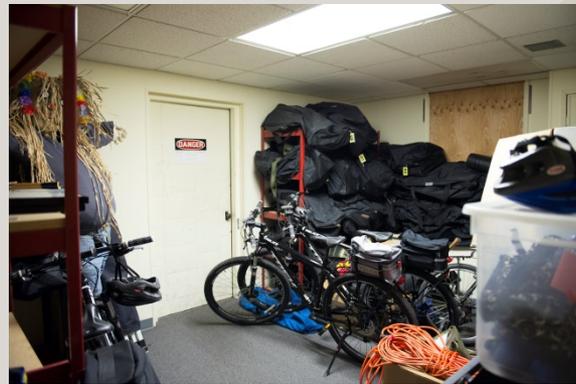
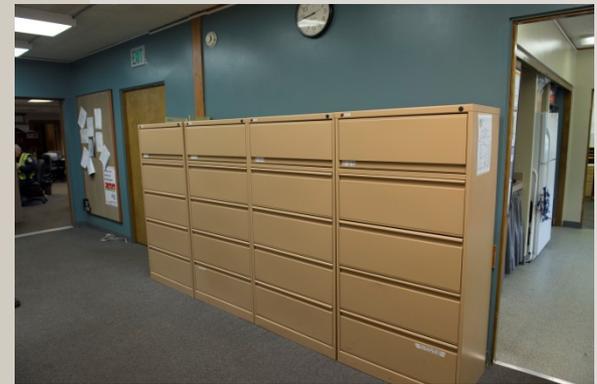
## Support Spaces and Systems Deficiencies

- No lockers rooms or showers
- Interview room being used as storage space
- Inadequate meeting space - Meetings held at fire station
- Inadequate storage – records files in hallway
- Chain of Custody Issues:
  - Employees must leave secured area to return evidence
  - Evidence tech desk located in evidence storage space.

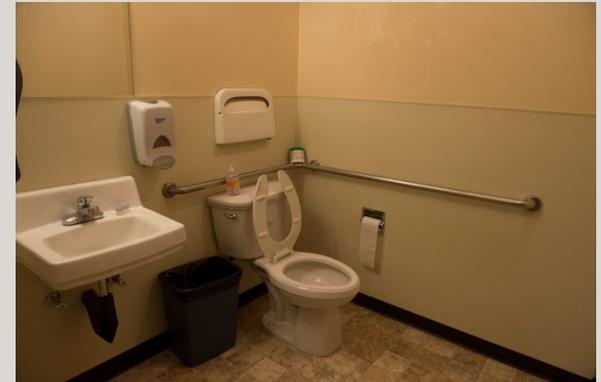
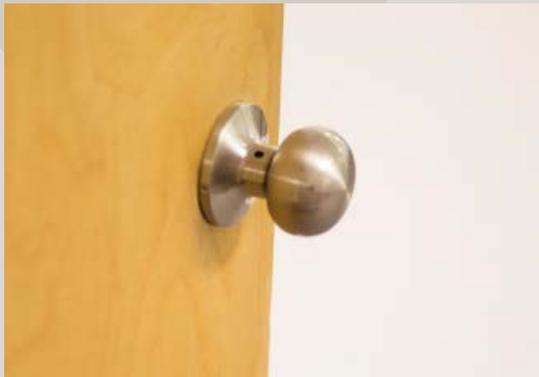
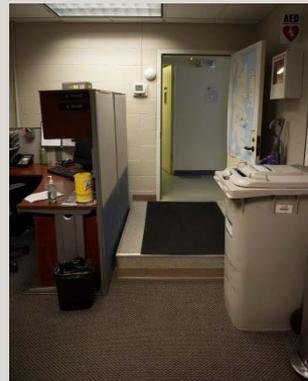
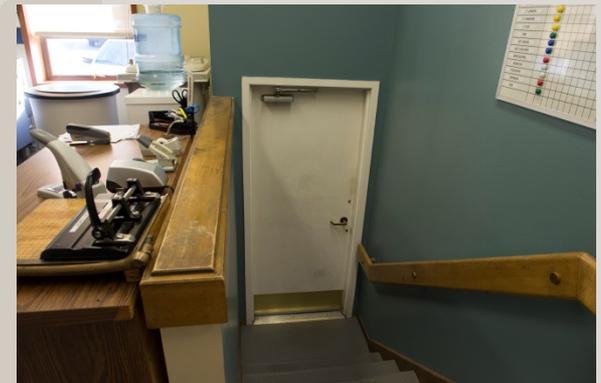
## ADA Deficiencies

- Non-ADA compliant ramp transitions
- Door hardware not ADA compliant
- Non-ADA compliant toilet rooms and kitchen
- Non-ADA compliant door thresholds and floor transitions
