POLICE

STATION SUMMARY

Police - Existing Facility

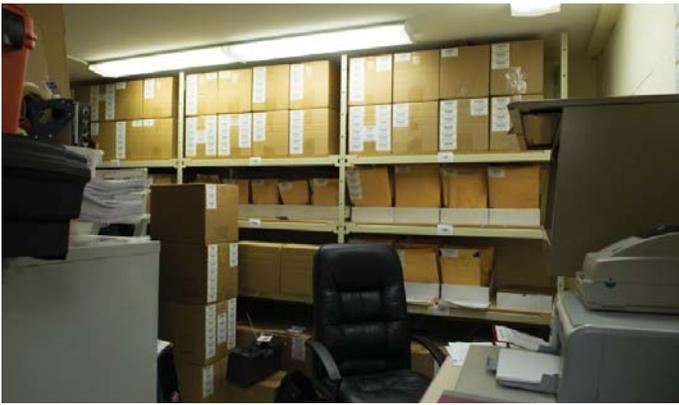
Evidence Storage

The evidence technician's desk is located within the evidence storage room, exposing the employee to constant interaction with potentially dangerous substances. Further, the cramped room does not provide enough storage space for the department's evidence needs.

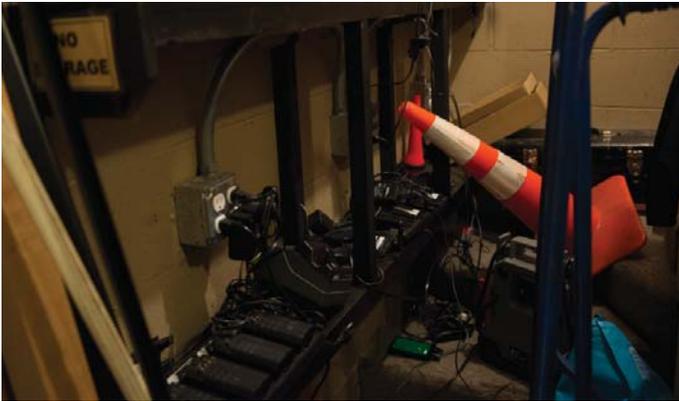
Radio Storage

In a narrow storage space adjacent to the former training tower stairs lie the radio charging stations. The space is cramped and difficult to access posing challenges to any quick response situation.

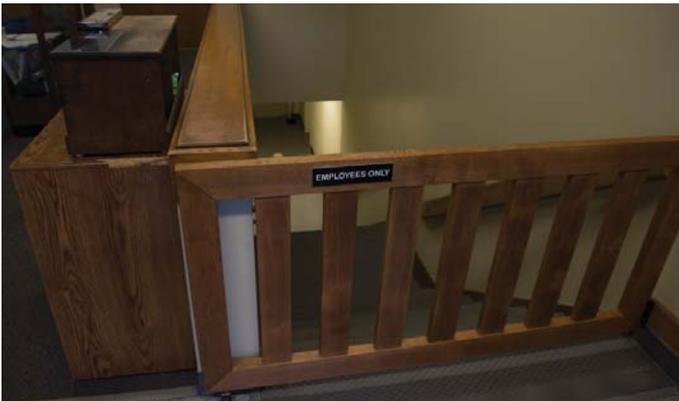
Vertical Circulation

Throughout the police department, vertical circulation is insecure and not in full compliance with current code. This image to the left shows the manually operated swing gate that divides public from police space in the lobby. Down the stairs lies evidence storage, the armory, and the detectives office.

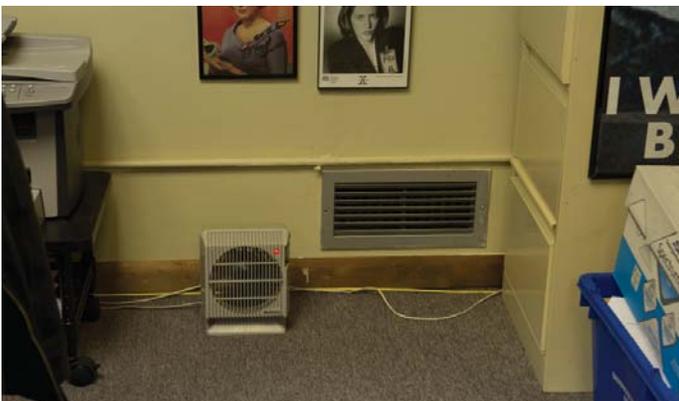
Utilities

Despite recently installed furnaces and heat pump units, the duct work seems to supply less than adequate heating and cooling to the building as a whole. This forces some areas, such as the detectives' office, to supplement the HVAC system with space heaters at an added utility cost.

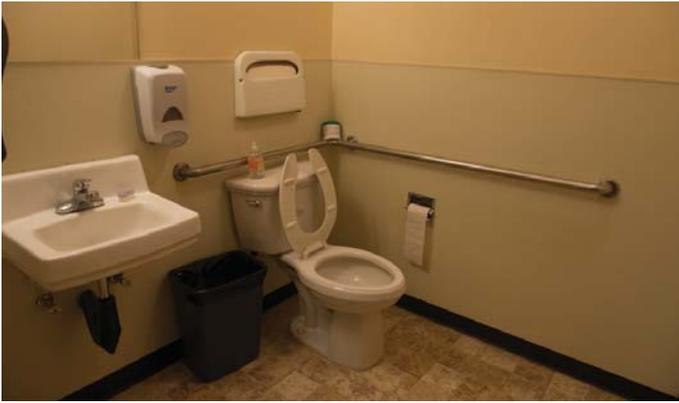
Toilet Room

Neither of the two restrooms are fully ADA compliant, one meets the spatial requirements though it lacks the vertical grab bar necessary. Both are accessed through the public lobby and pose a security risk to officers and staff.

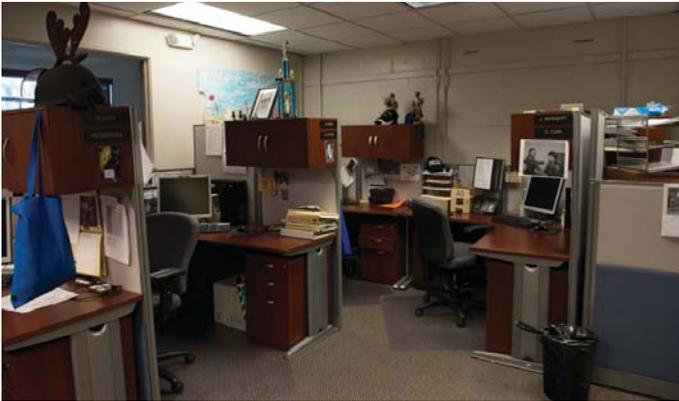
Patrol Workstations

Workstations are filled to capacity for efficient operation. There is not sufficient space for the equipment needed in a modern police station.

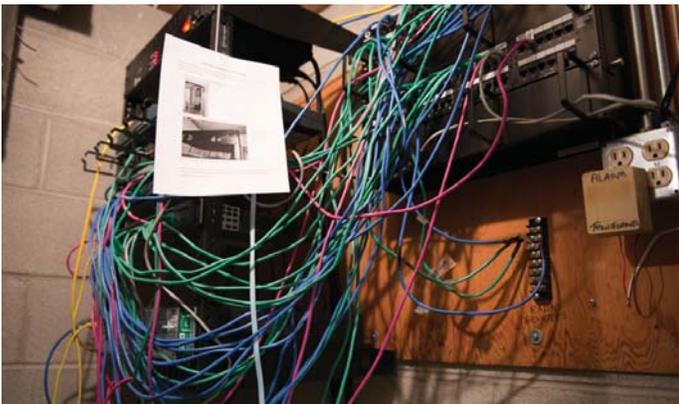
Technology/Server Room

Located within a mechanical room, the server and technology space is cluttered and patched together. A lack of air conditioning in the space could become a concern in warmer weather.

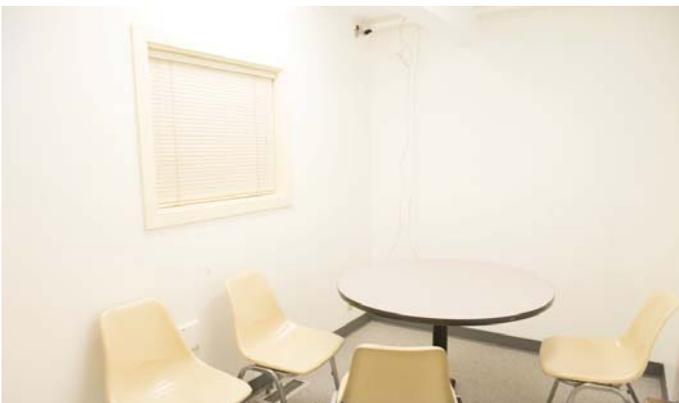
Interview Rooms

The interview rooms lack the proper technology to effectively record meetings and provide security and privacy for the police, victims, and suspects.

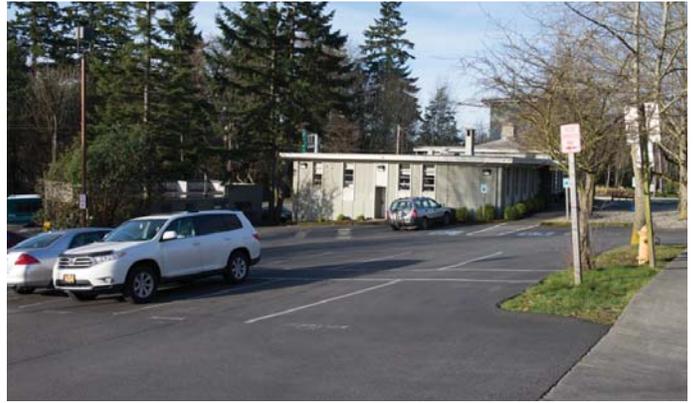
Exterior/Site

Adjacent to the ferry terminal, access to the Department is subject to the ebb and flow of commuter traffic backups.

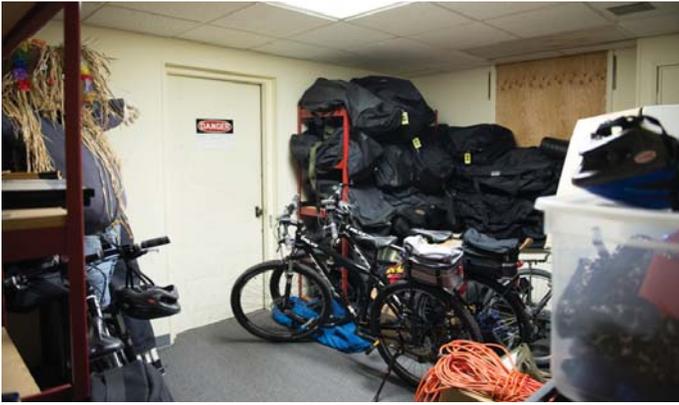
Equipment Storage

Bicycles, SWAT gear and other equipment are layered into the equipment storage room, creating unorganized clutter that is difficult to access.

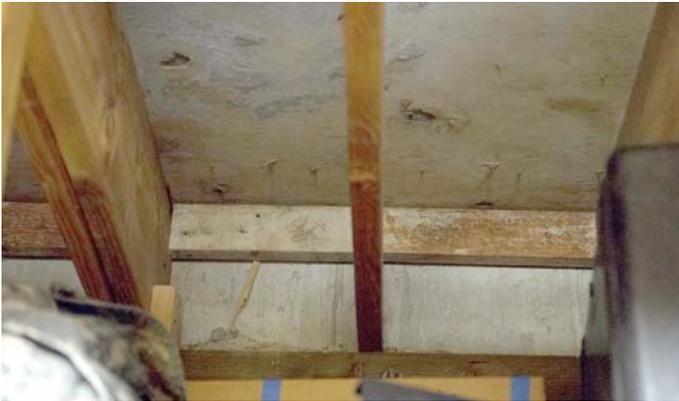
Structural Connections

Lack of appropriate wall to diaphragm anchorage

Exterior masonry walls need to be anchored for out-of-plane forces to the diaphragms (roof and main floors).

Roof and floor diaphragms should be connected to the masonry walls in such a way that can transfer shear forces. Although access to view these connections was not available, it is unlikely that the masonry walls have adequate connections.

Floor diaphragm to masonry wall connections are inadequate for both in-plane and out-of-plane shear forces. The image to the left, which shows the existing condition, lacks the anchorage/strapping that is required by current seismic code.

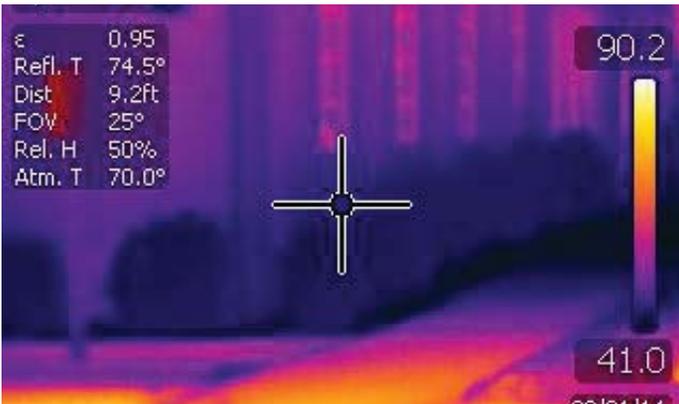
Infrared Imaging

The northeast corner of the building shows significant thermal loss through the window frames.

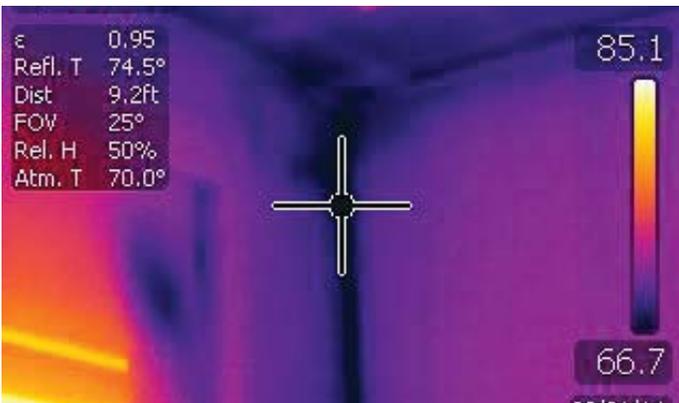
Infrared Imaging

The Chief's office shows significant thermal loss at the exterior walls.

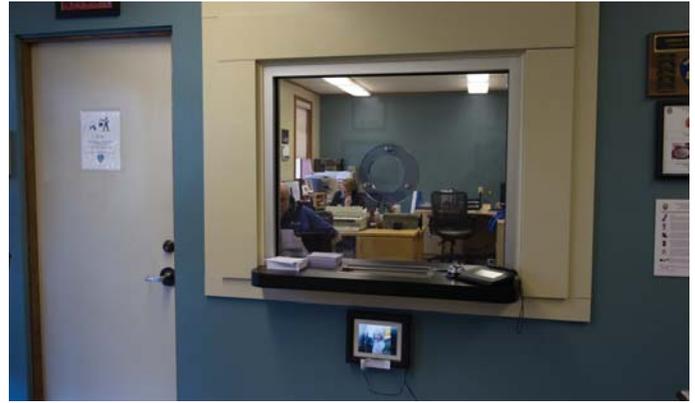
Reception

Upon entering the compact lobby space, one immediately comes across the transaction counter. While bullet resistant glass is used, employees and computer screens are clearly visible for all. Further, the adjacent hollow metal door does not meet the necessary security requirements.

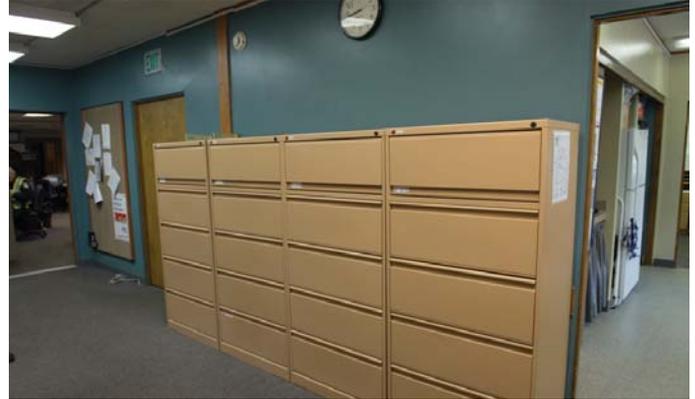
Records Storage

Record files are stored in locked, yet unsecured file cabinets available to all employees.
