City of Bainbridge Island

Traffic Report

Focused Traffic Study

December 11, 2013

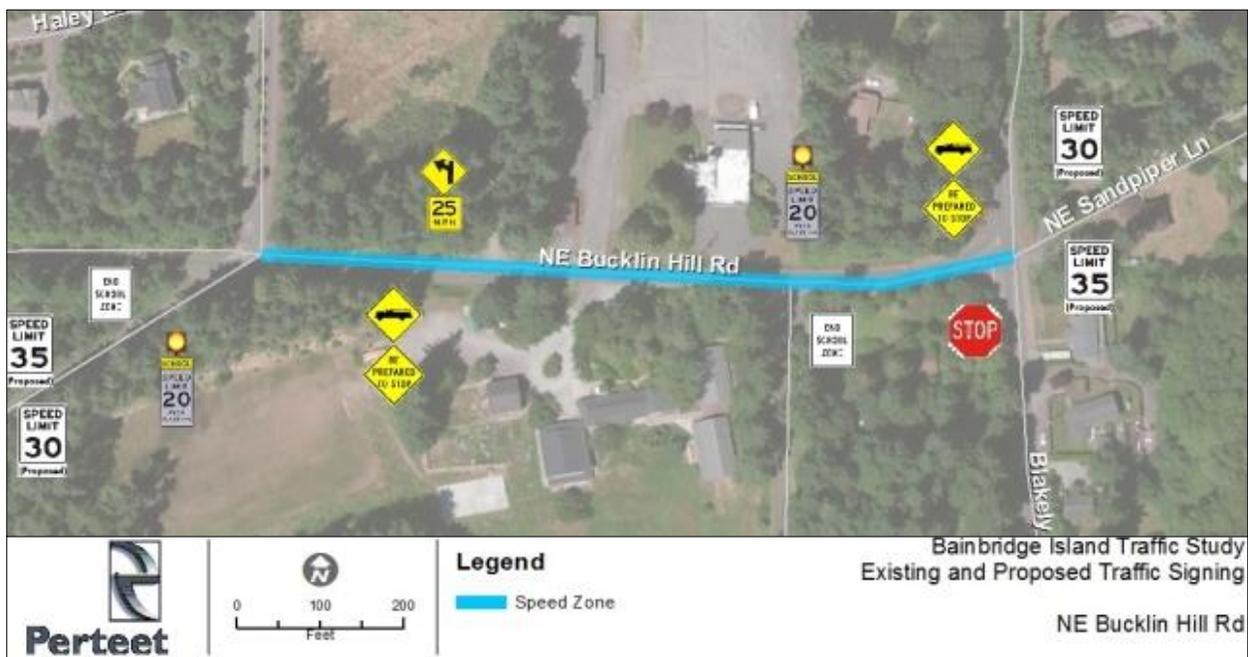
Figure 3-4: Proposed NE Bucklin Hill Rd signing

The 85th percentile of 35.8 mph means that the currently posted speed limit of 35 mph is being followed by a majority of the vehicles on the roadway segment. Speed zoning theory best practices recommend that the 85th percentile speed be captured below the posted speed limit in most cases, suggesting that the speed limit should be increased to 40 mph. However, the difference between the posted speed limit and the 85th percentile speed is minimal. With this sample, a lower posted speed limit would increase the percentage of drivers exceeding the posted limit from 15% (at 35 mph) to 53% (at 30 mph).

1. Reduce the posted speed limit in this segment of the corridor from the existing 35 mph to 30 mph until planned roadway improvements to provide segregated non-motorized facilities are in place. Figure 3-4 provides a possible signing configuration for the segment.

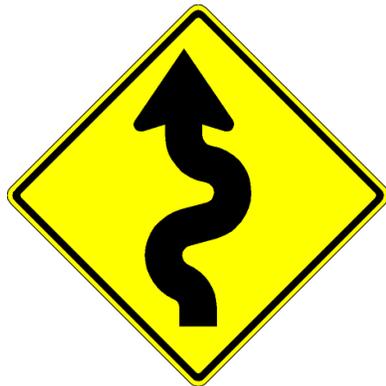
may present a larger challenge for drivers. During the speed survey, multiple vehicles passed each other near curves and slowed down in order to do so. To improve safety, W1-5 curve warning signs with a 20-mph recommended speed (W13-IP) should be installed.

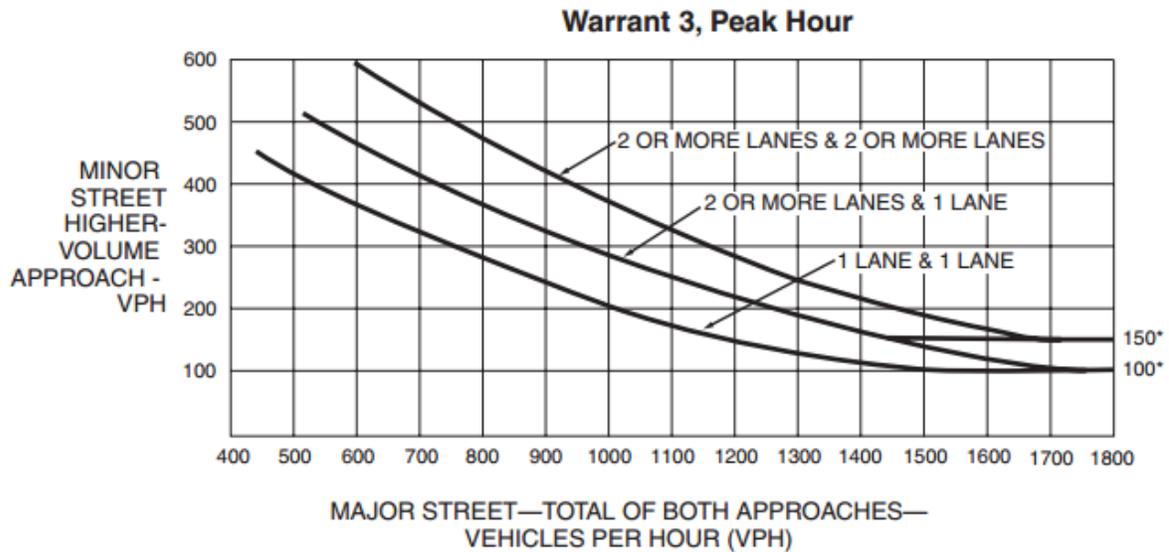
Figure 10-4: MUTCD traffic signal peak hour warrant

The major street (Lynwood Center Rd NE) volume for this intersection during the peak hour is 358, while the minor street higher volume approach (NE Baker Hill Rd, eastbound) is 51. The minimum required peak hour volume for the minor street higher volume approach is 100 vehicles. The volumes do not meet this warrant and are not expected to meet either the four- or eight-hour warrants.

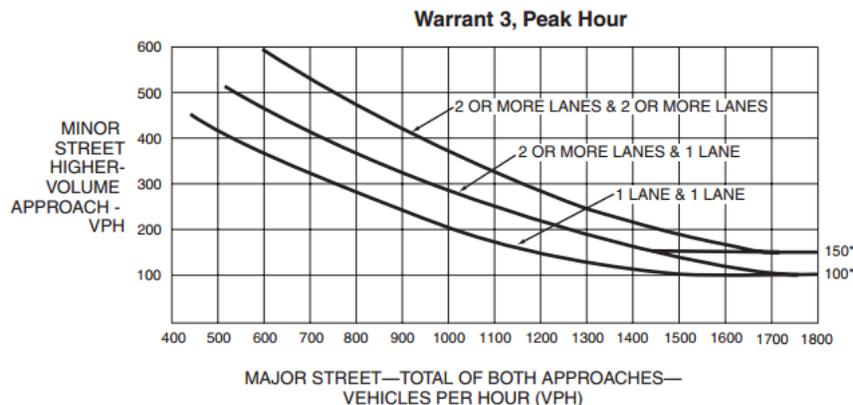
Figure 11-4: MUTCD traffic signal peak hour warrant

The major street (Miller Rd NE) volume for this intersection during the peak hour is 360, while the minor street higher volume approach (NE Koura Rd, WB) is 72. The minimum required peak hour volume for the minor street higher volume approach is 100 vehicles. The volumes do not meet this warrant and are not expected to meet either the eight- or four-hour warrant.

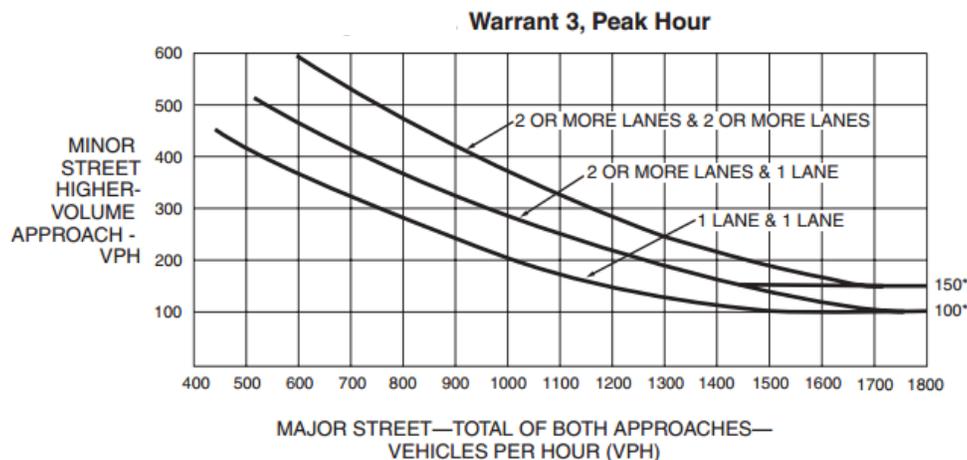
Figure 12-4: MUTCD traffic signal peak hour warrant

The major street (NE Valley Rd) volume for this intersection during the peak hour is 192, while the minor street higher volume approach (Sunrise Dr NE, SB) is 71. The minimum required peak hour volume for the minor street higher volume approach is 100 vehicles. The volumes do not meet this warrant and are not expected to meet either the eight- or four-hour warrant.
