4.0 SITE ASSESSMENT METHODS AND EVALUATION CRITERIA

5.0 SITE EVALUATION RESULTS

**CoBI Water Quality and Flow Monitoring Program
Site Evaluation Form
Land Locations**

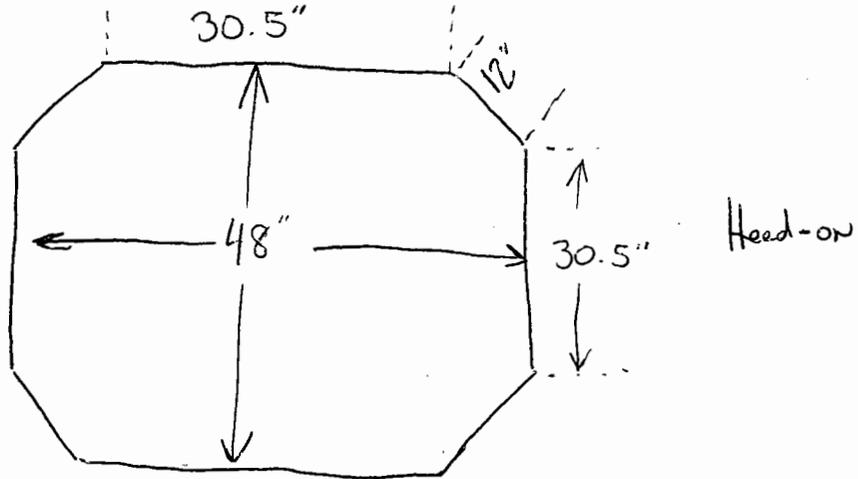
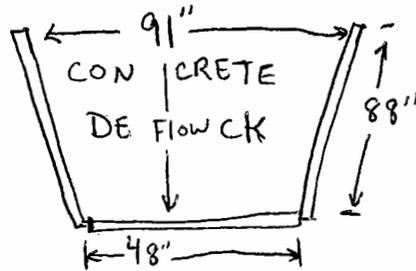
Top View - looking down
onto entry spillway
(culvert entrance)

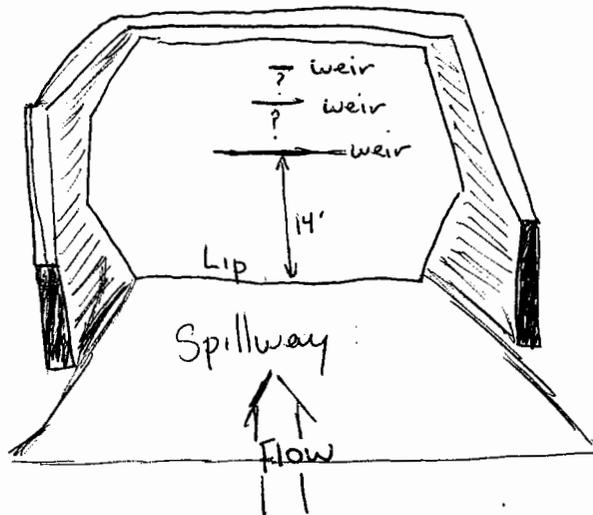
Drawing No. 002
Site Location: #1 SE

weir plates (4x4" timbers)
at step down points
