Attachment A – Country Club Road Failure Background

Background and Context

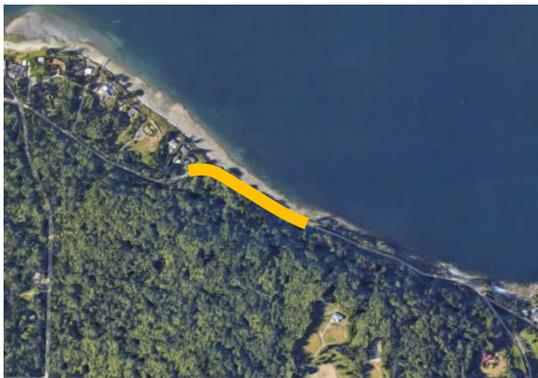
The yellow line indicates the stretch of road currently failing along the shoreline. Toe Jam Hill on the left, Upper Farms Road on the lower right.

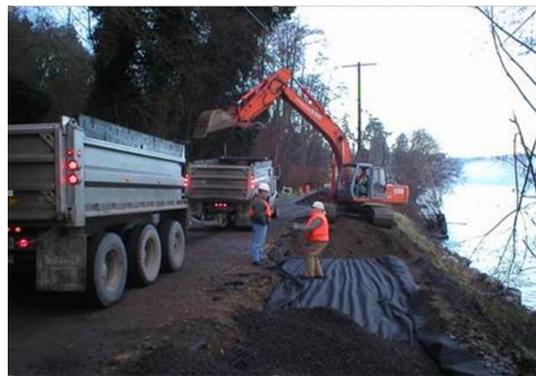
City contractors performing shoreline stabilization repairs in 2005.

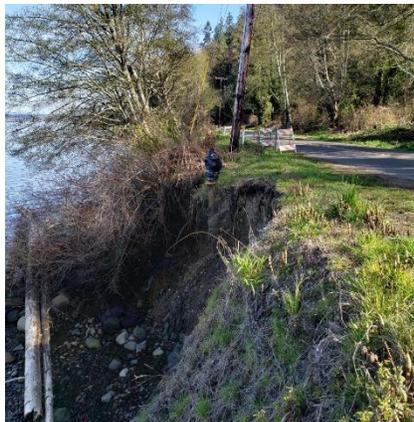
The failing section of roadway identified above has been rapidly changing over the course of the last several years. A majority of the existing bulkhead that was constructed in 2005, and subsequently repaired, has failed, leaving the underlying soils exposed and subject to erosion. On the western end of this section, there was a massive failure of the bulkhead, which has left a KPUD fire hydrant and a PSE utility pole exposed and in need of relocation (see photo 1 below.) This stretch is located on a

1. This section of the bulkhead is failing at the curve in the road. Note the fire hydrant and utility pole exposed at the top of the slope.

For the last year, Public Works Engineering has been working with a consultant to design and permit a bulkhead repair and reconstruction project that would stabilize the shoreline along the subject stretch of road. The design plans for the bulkhead, which are currently at 90%, also include the repair and relocation of drainage culverts along the stretch of road, as well as minor repairs along the westbound lane edge. The project is estimated to cost approximately \$375K, but there is currently no funding allocated in the 2019-20 biennial budget. Permits for construction of the project have been received by the City's Planning Department, the State Department of Fish and Wildlife. The project also requires a permit from the Corps of Engineers (COE), and City staff are

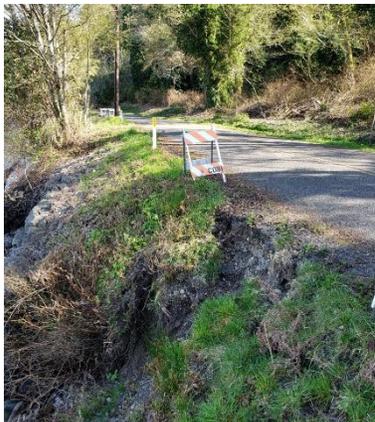
curve, and there still exists between 10' and 15' of gravel shoulder waterward of the roadway. In the middle and eastern end of this section, there have been localized failures of the bulkhead, and there is no shoulder remaining to protect the road. In several areas along this stretch, the slope failure is undermining the pavement at the westbound lane edge or is about to do so (see photos 2 and 3 below).

2. This slope failure is impacting the pavement at the edge of the westbound travel lane.

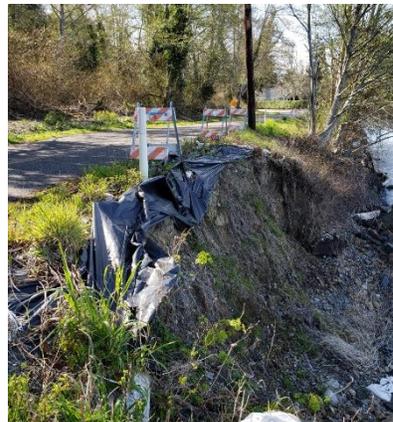
3. This slope failure is about to impact the pavement at the edge of the westbound travel lane. This is same area as the 2005 photo above – note the lack of uplands where a backhoe was once able to travel.

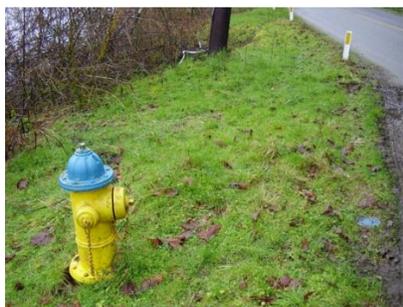
January 30, 2006

The following time-lapse photos of the westbound (shoreline side) of the road edge also provide a compelling picture of the rapid changes occurring at the top of the slope:
