## **Technical Memorandum**

<b>Date:</b>	May 20, 2022	<b>From:</b>	Jennifer H. Saltonstall, L.Hg.
<b>To:</b>	Herrera Environmental Consultants, Inc.	<b>Project Manager/ Principal in Charge:</b>	Jennifer H. Saltonstall, L.Hg.
<b>Attn:</b>	Matt Fontaine, P.E.	<b>Project Name:</b>	Manzanita Watershed Hydrogeologic Evaluation
	mfontaine@herrerainc.com	<b>Project No:</b>	20210159H001
<b>Subject:</b>	Infiltration Feasibility Assessment, Subtask 2.1c and Subtask 2.1d

MANZANITA WATERSHED HYDROGEOLOGIC EVALUATION  
 BAINBRIDGE ISLAND, WASHINGTON

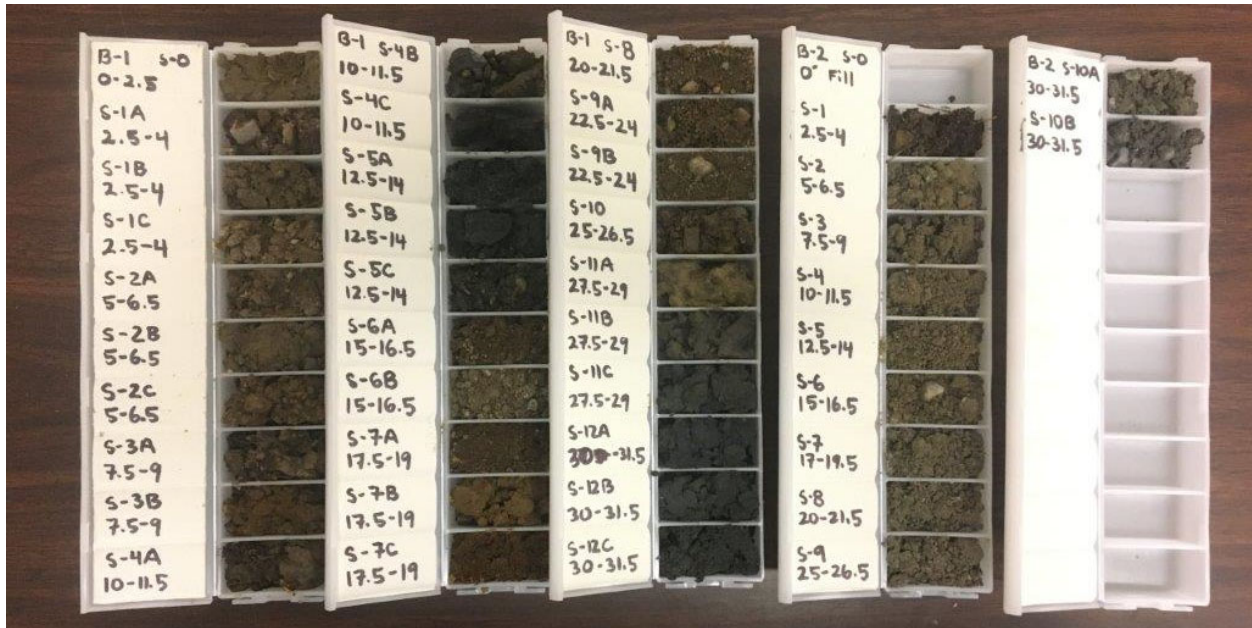
Photo 1. Reference sample trays created from samples for exploration borings B-1 and B-2.

The samples obtained from the split-barrel sampler were classified in the field and representative portions placed in watertight containers. The samples were then transported to AESI’s laboratory for further visual classification and laboratory testing, as necessary. Smaller portions of the samples were placed into trays for visual reference (see Photo 1). The exploration logs presented in Appendix A are based on the N-values, AESI’s review of the samples, field observations and drilling action observations by City of Bainbridge Island staff, and laboratory test results, if conducted.

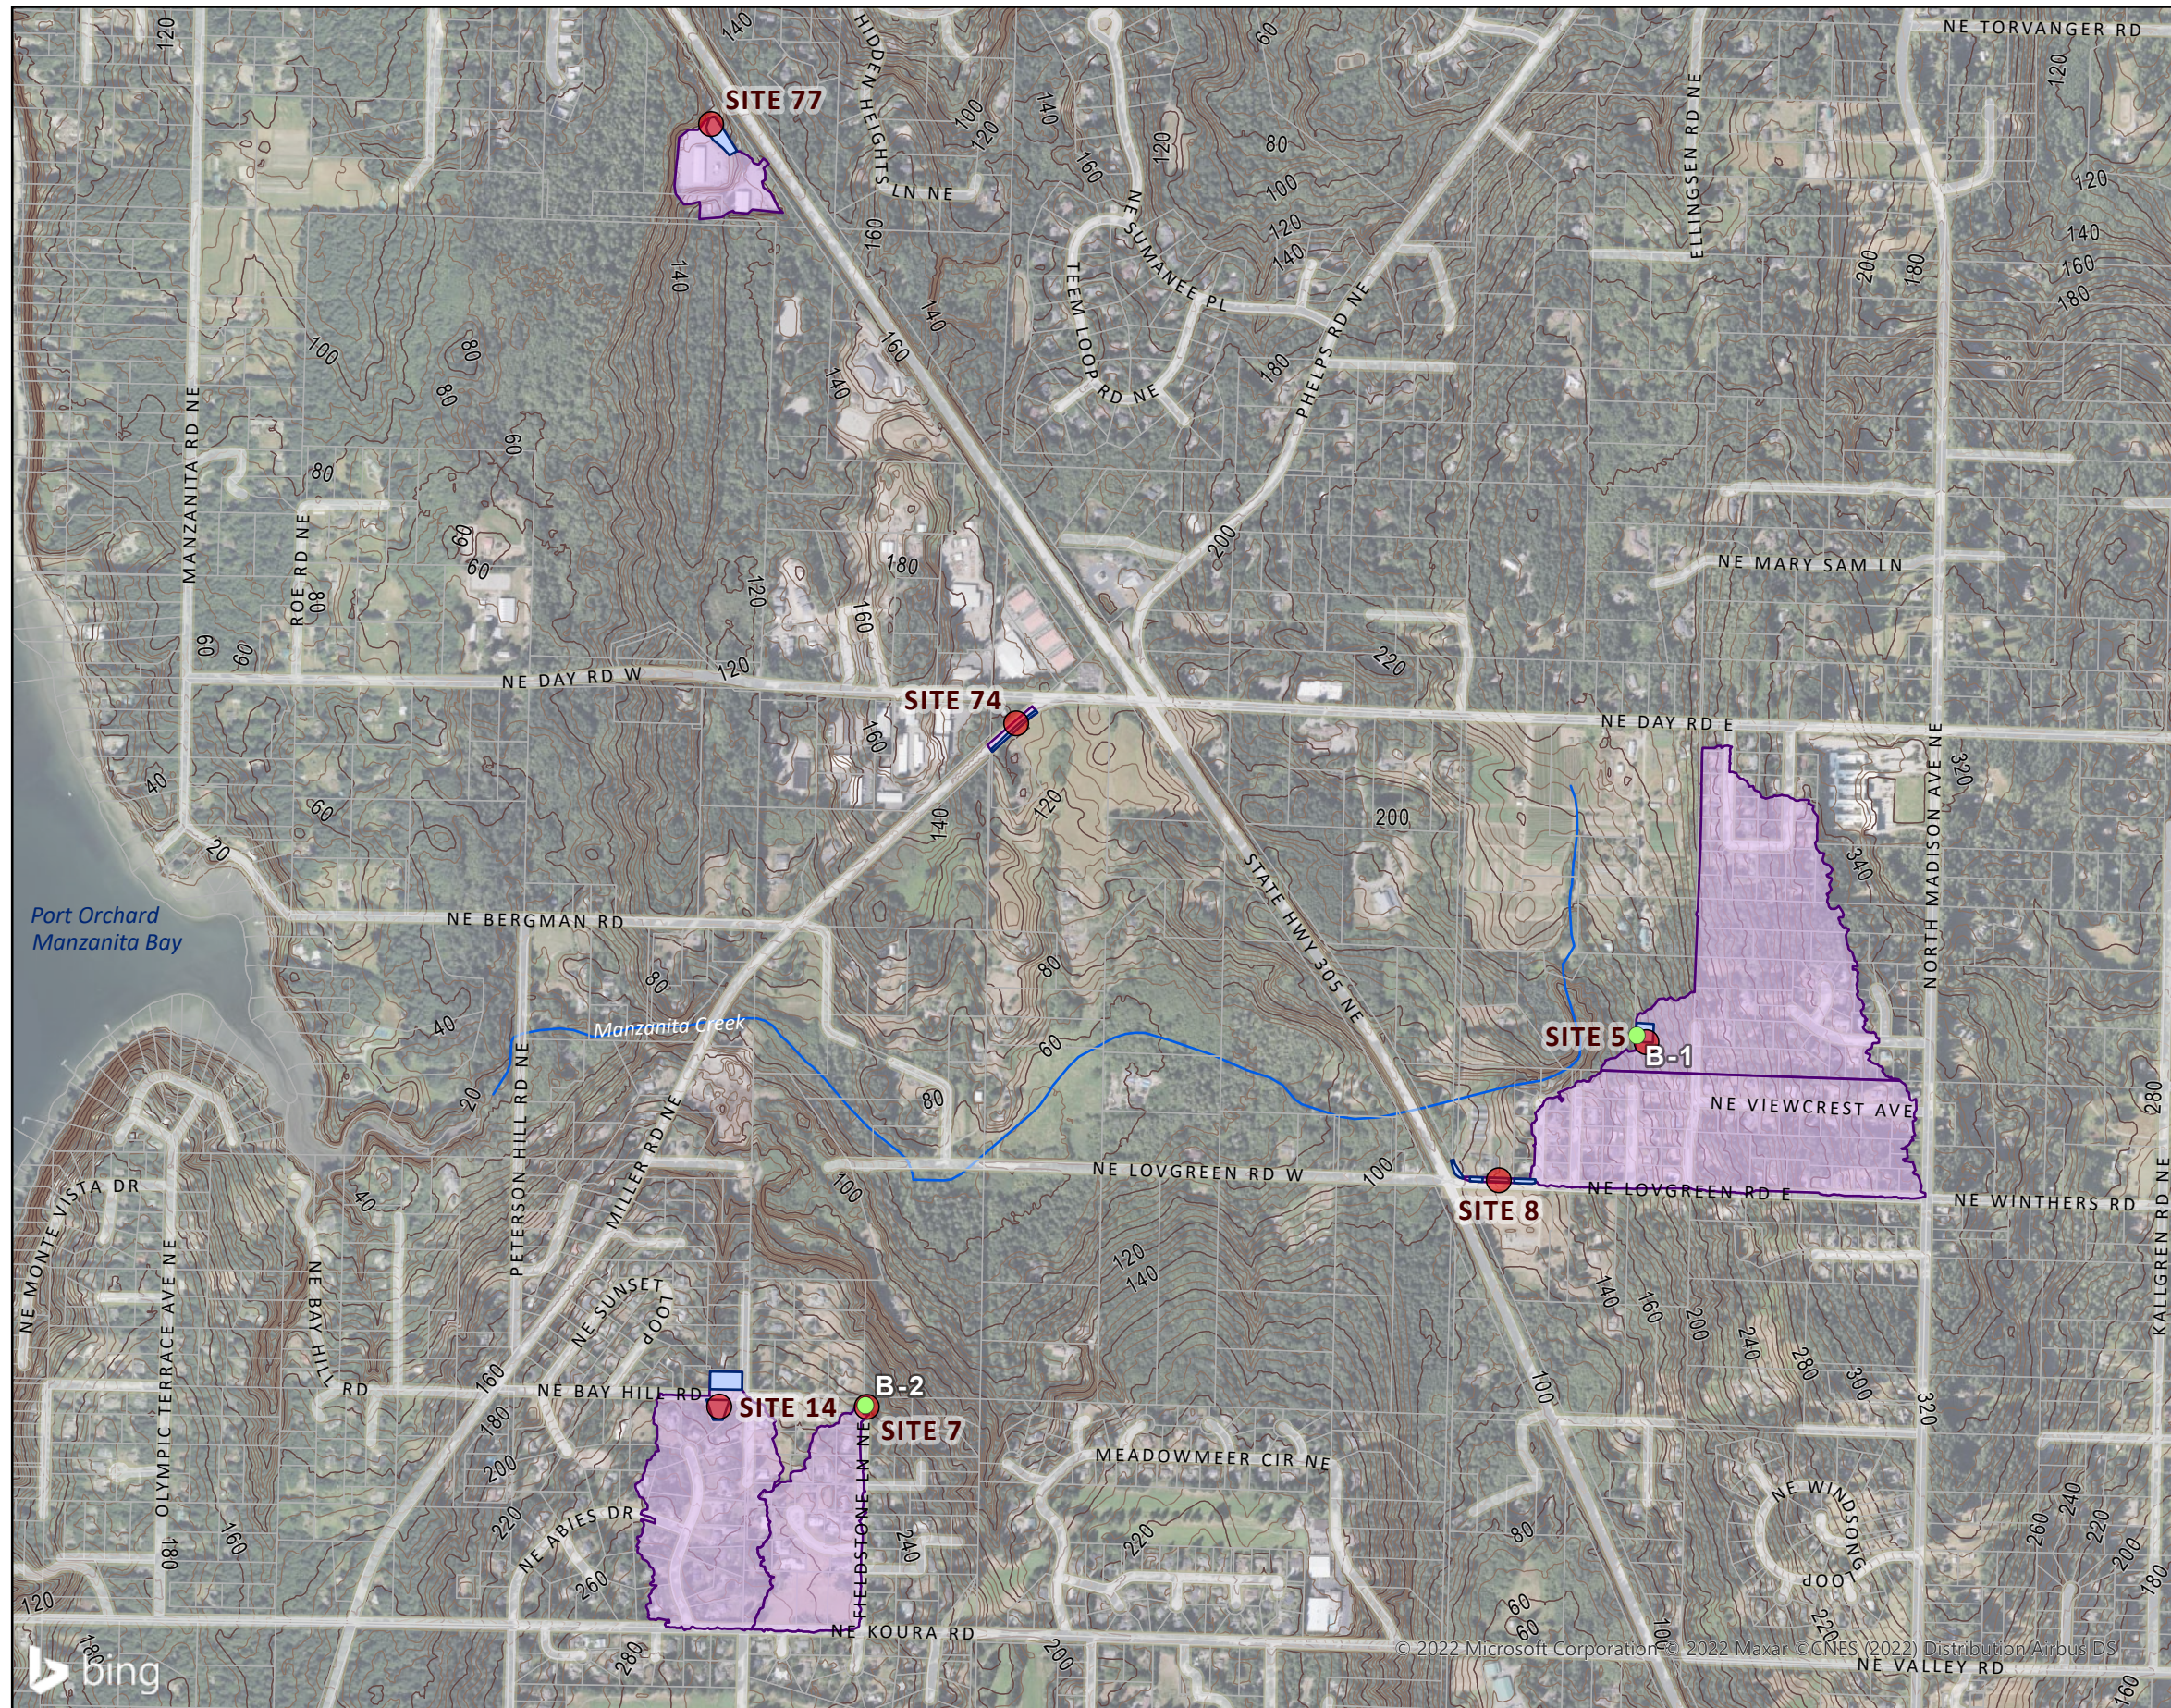
PROJ NO. 20210159H001	DATE: 4/22	FIGURE: 2
--------------------------	---------------	--------------

**EXPLORATIONS AND TOPOGRAPHY**  
 MANZANITA WATERSHED HYDROGEOLOGIC EVALUATION  
 BAINBRIDGE ISLAND, WASHINGTON

Two exploration borings (referred to as B-1 and B-2, located at Site 5 and Site 7, respectively) were drilled by Holt Services, Inc. under subcontract to the City of Bainbridge Island on March 7, 2022. The exploration borings were observed and logged by a City of Bainbridge Island hydrogeologist. The borings were drilled with a Mobile B-60 hollow stem auger drilling rig with 4-inch tooling to depths of 30 feet at the locations shown on Figure 2.

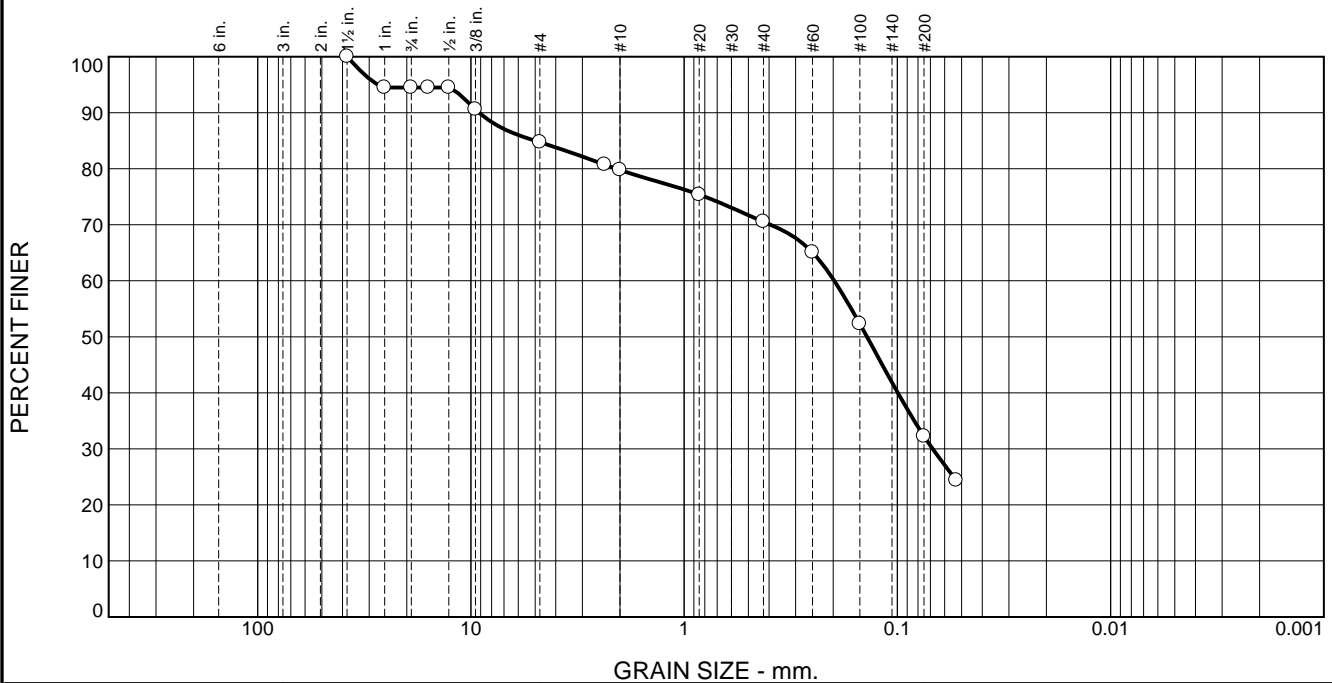
# Particle Size Distribution Report

% +3"	% Gravel		% Sand			% Fines	
	Coarse	Fine	Coarse	Medium	Fine	Silt	Clay
0.0	5.5	9.8	4.9	9.3	38.2	32.3

TEST RESULTS			
Opening Size	Percent Finer	Spec.* (Percent)	Pass? (X=Fail)
1.5"	100.0		
1"	94.5		
3/4"	94.5		
5/8"	94.5		
1/2"	94.5		
3/8"	90.6		
#4	84.7		
#8	80.7		
#10	79.8		
#20	75.4		
#40	70.5		
#60	65.1		
#100	52.3		
#200	32.3		
#270	24.4

very silty, gravelly SAND

USCS (D 2487)= SM                      AASHTO (M 145)= A-2-4(0)

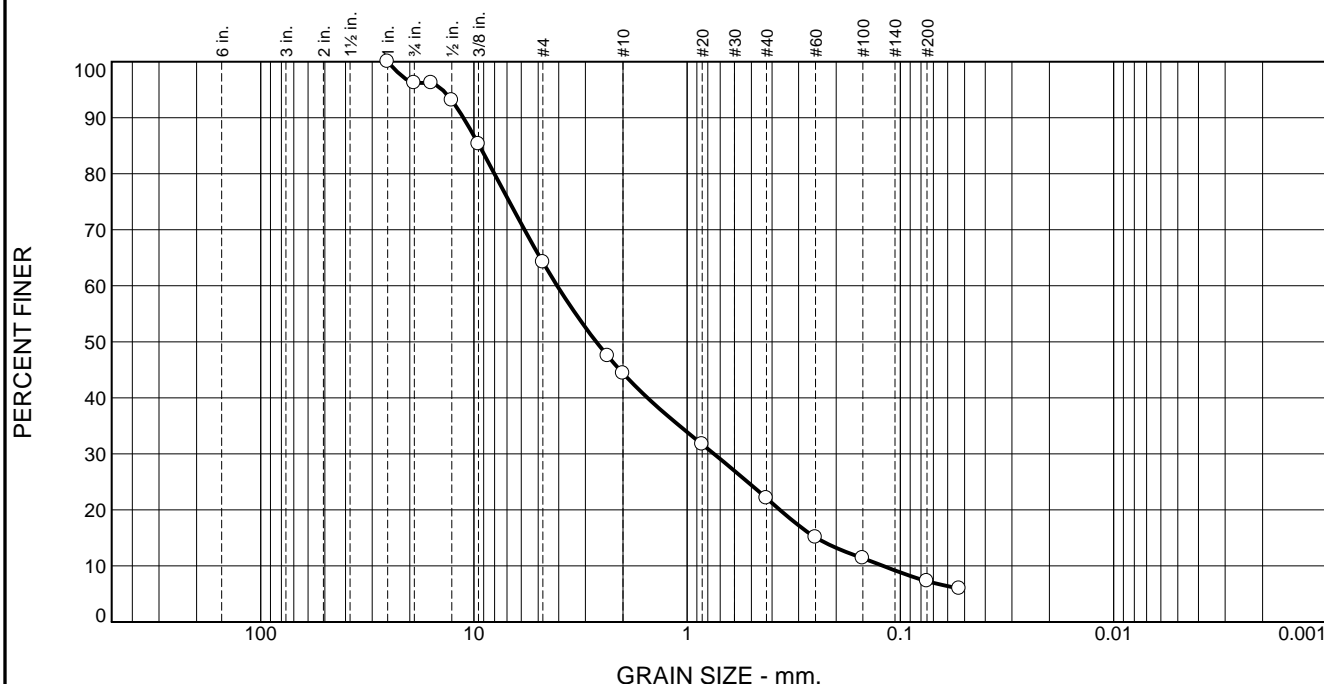
# Particle Size Distribution Report

% +3"	% Gravel		% Sand			% Fines	
	Coarse	Fine	Coarse	Medium	Fine	Silt	Clay
0.0	3.8	32.0	19.8	22.3	14.8	7.3

TEST RESULTS			
Opening Size	Percent Finer	Spec.* (Percent)	Pass? (X=Fail)
1"	100.0		
3/4"	96.2		
5/8"	96.2		
1/2"	93.1		
3/8"	85.3		
#4	64.2		
#8	47.5		
#10	44.4		
#20	31.7		
#40	22.1		
#60	15.1		
#100	11.4		
#200	7.3		
#270	6.0

AESI conducted grain size distribution tests (sieves) on samples of the pre-Vashon coarse-grained sediments at depths of 15 and 20 feet below ground surface. We then compared the sieve results to with AESI's internal pilot infiltration test results database for the following estimated infiltration rates:

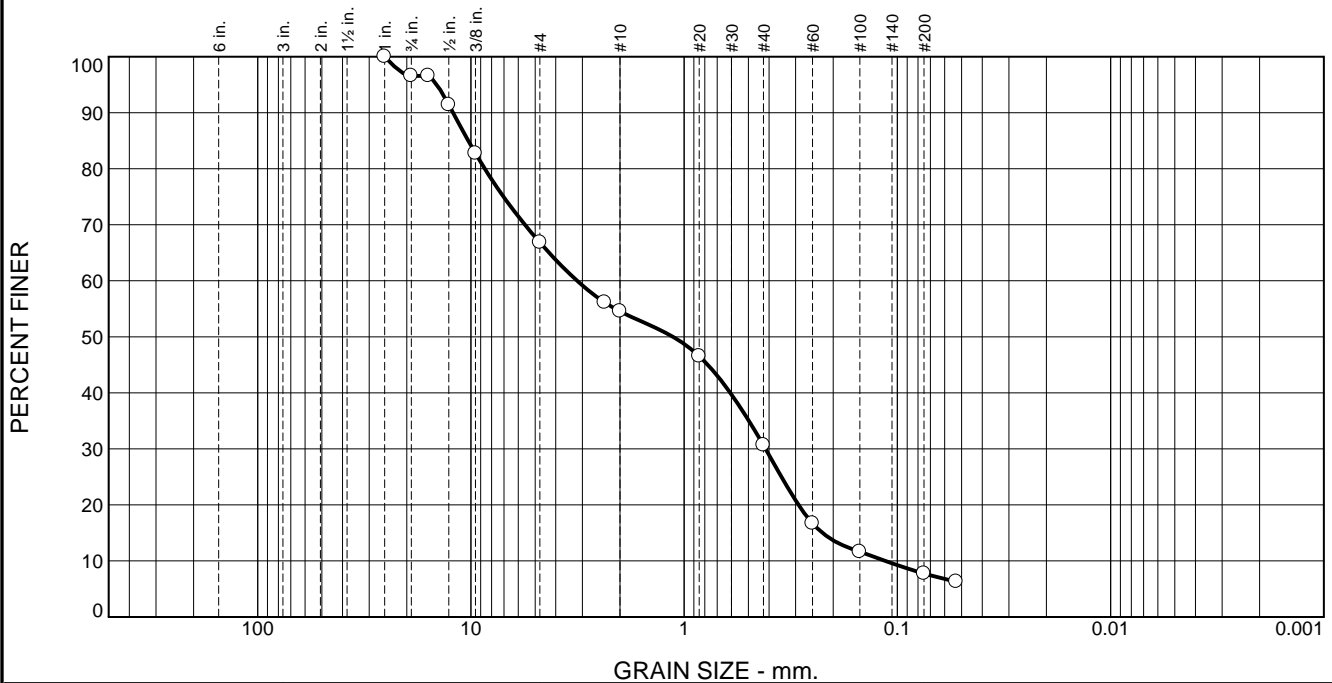
# Particle Size Distribution Report

% +3"	% Gravel		% Sand			% Fines	
	Coarse	Fine	Coarse	Medium	Fine	Silt	Clay
0.0	3.4	29.8	12.3	23.8	23.0	7.7

TEST RESULTS			
Opening Size	Percent Finer	Spec.* (Percent)	Pass? (X=Fail)
1"	100.0		
3/4"	96.6		
5/8"	96.6		
1/2"	91.4		
3/8"	82.8		
#4	66.8		
#8	56.1		
#10	54.5		
#20	46.5		
#40	30.7		
#60	16.7		
#100	11.6		
#200	7.7		
#270	6.3

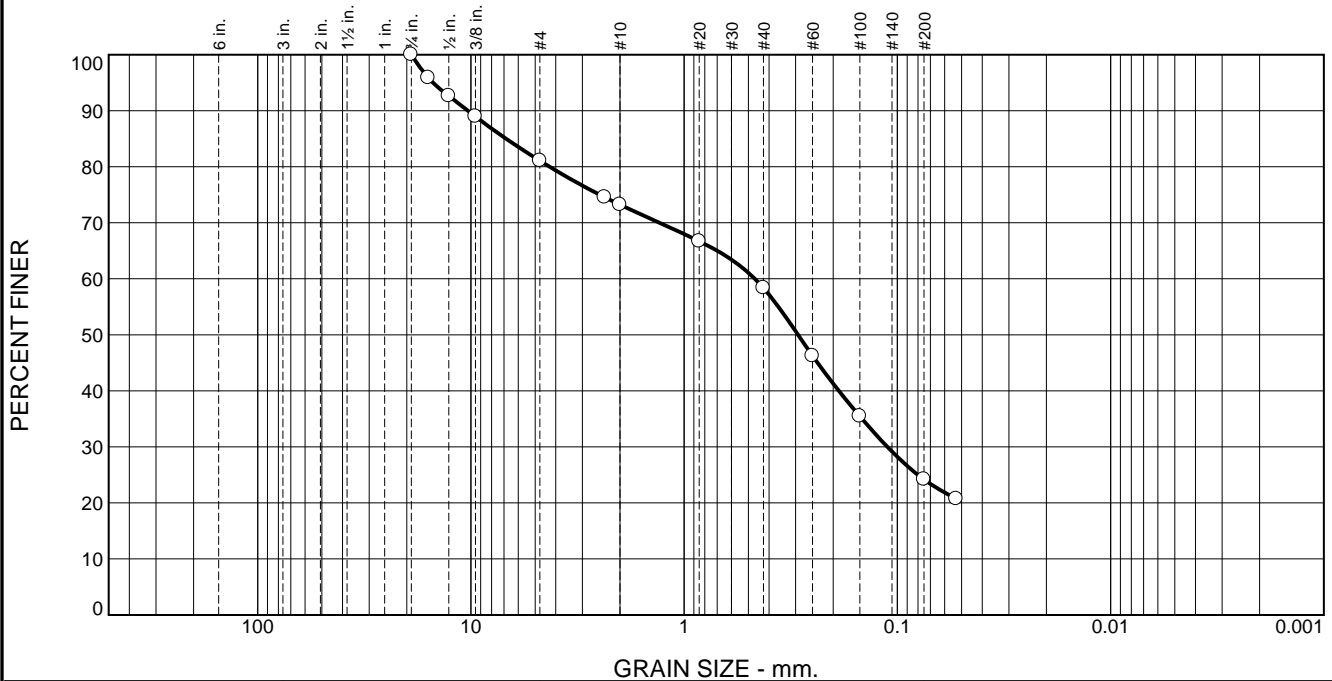
# Particle Size Distribution Report

% +3"	% Gravel		% Sand			% Fines	
	Coarse	Fine	Coarse	Medium	Fine	Silt	Clay
0.0	0.0	18.9	7.9	14.8	34.2	24.2

TEST RESULTS			
Opening Size	Percent Finer	Spec.* (Percent)	Pass? (X=Fail)
3/4"	100.0		
5/8"	95.9		
1/2"	92.6		
3/8"	89.0		
#4	81.1		
#8	74.6		
#10	73.2		
#20	66.7		
#40	58.4		
#60	46.3		
#100	35.5		
#200	24.2		
#270	20.7
