BAINBRIDGE ISLAND NEARSHORE HABITAT CHARACTERIZATION & ASSESSMENT, MANAGEMENT STRATEGY PRIORITIZATION, AND MONITORING RECOMMENDATIONS

BAINBRIDGE ISLAND NEARSHORE HABITAT
CHARACTERIZATION & ASSESSMENT,
MANAGEMENT STRATEGY PRIORITIZATION,
AND MONITORING RECOMMENDATIONS

November 2004

Prepared for
City of Bainbridge Island

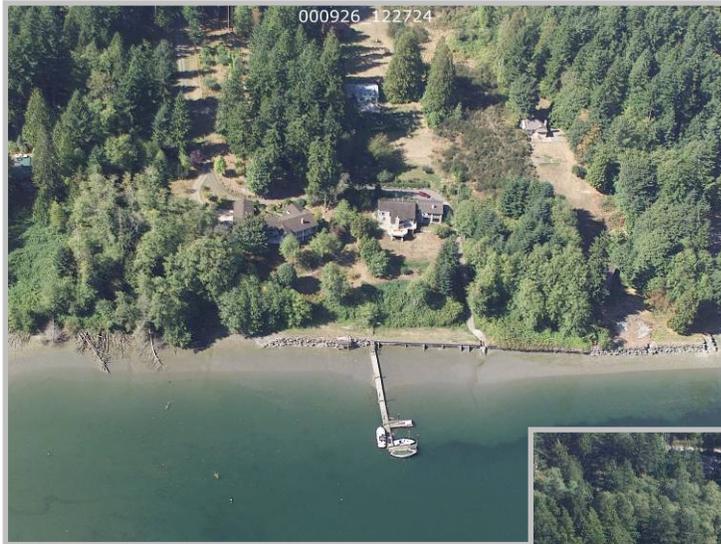
- *Low Bank* – (photo example at left) slope often greater than 40% (though not very wide); usually greater than 15%; height less than 5 meters; usually narrow foreshore (beach) with high water line at or on the bank; trees at waterline often indicate low bank rather than beach or wide backshore class; raised bedrock terraces assigned low bank if characterized by a sand and gravel beach; backed by low scarp

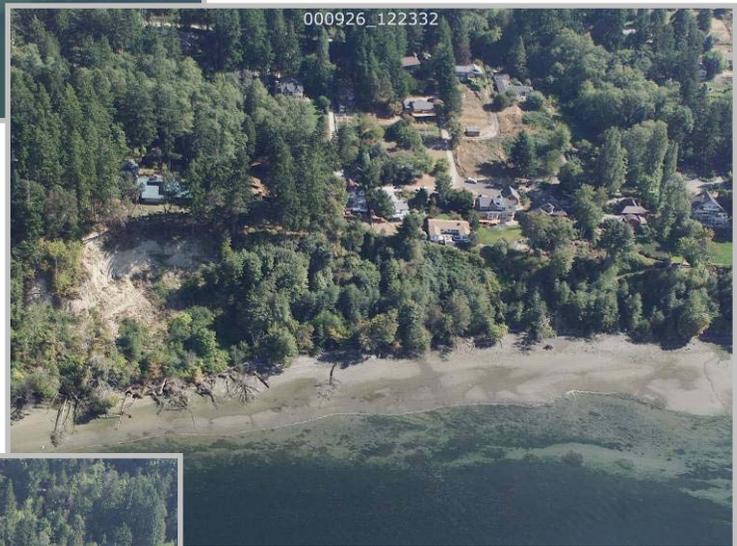
- *High Bluff* – (photo example at right) slope greater than 40%; height greater than 5 meters (estimated from aerial photo, GIS verified); often unstable or with visible face (little or no vegetation); sediment source often from backshore; high stairs and setback houses also indicate bluff

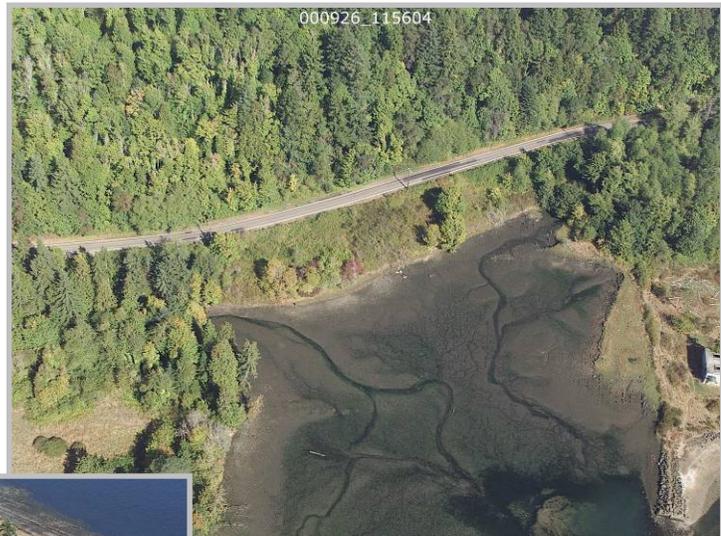
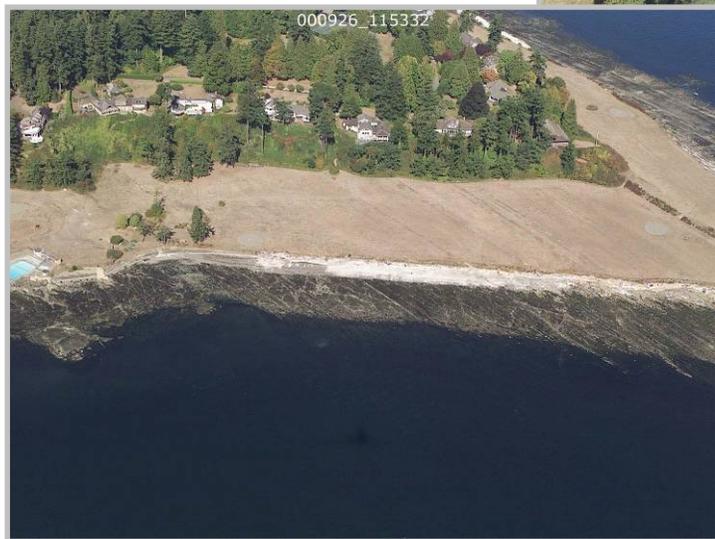
- *Spit/Barrier/Backshore* – (photo example at left) wide beach face; slope <15%; wide backshore is key to distinguishing between bank and beach; spits and barrier beaches are generally self-evident

- *Marsh/Lagoon* – (photo example at right) protected embayments, often with fluvial sediment sources; substrate is composed of fines; diagnostic salt marsh vegetation; lagoons may empty completely at low tide (extensive tide flats) and may have a residual basin that holds water at low tide

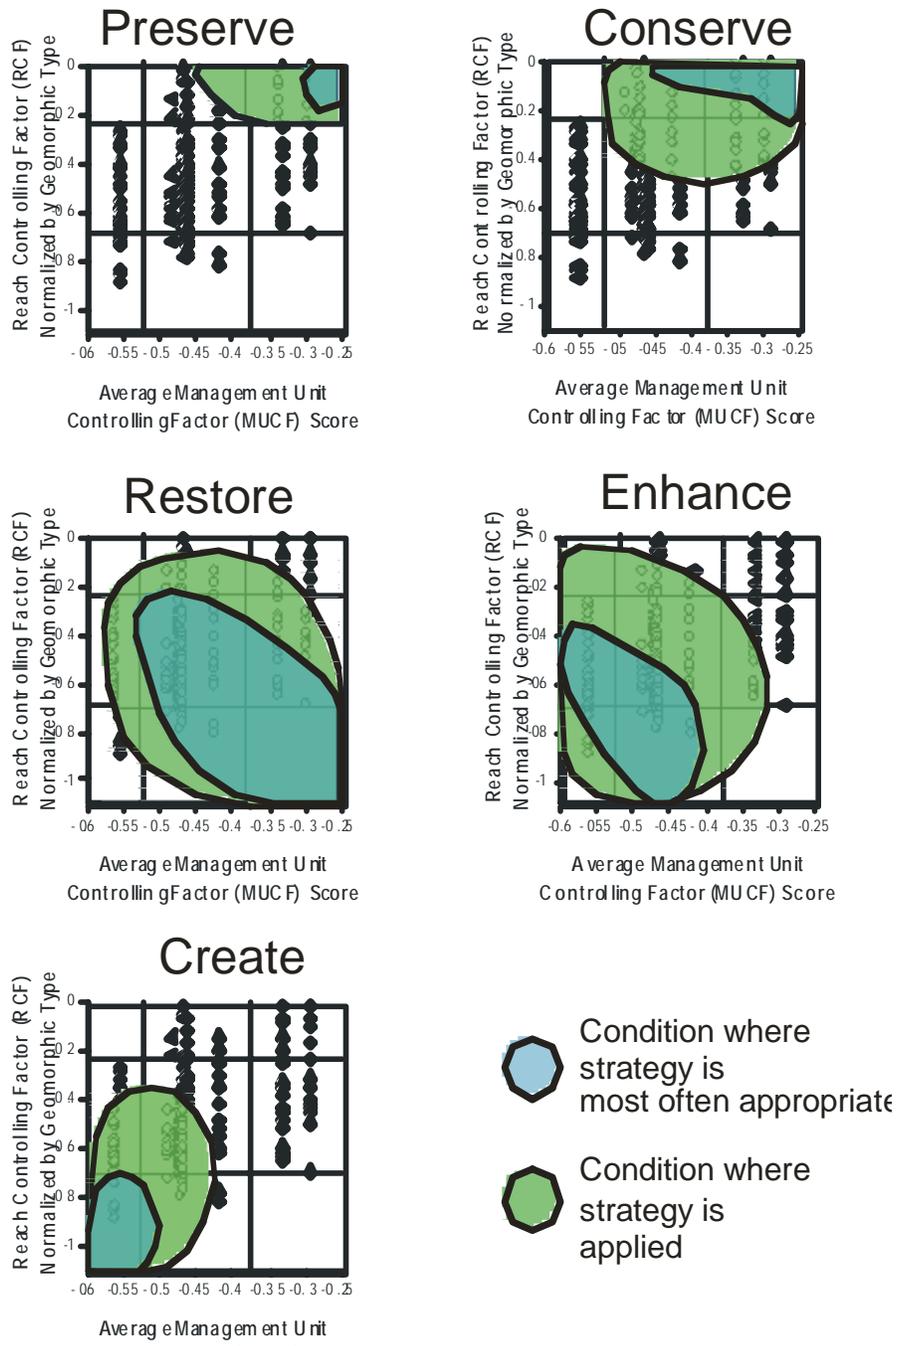
Figure E-4. Generalized zones of application of management strategies relative to management area and reach disturbance.
