# City of Bainbridge Island & Bainbridge Island Fire Department

Facilities Assessment

March 05, 2014

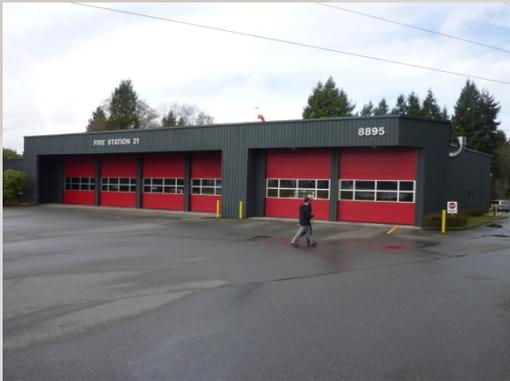
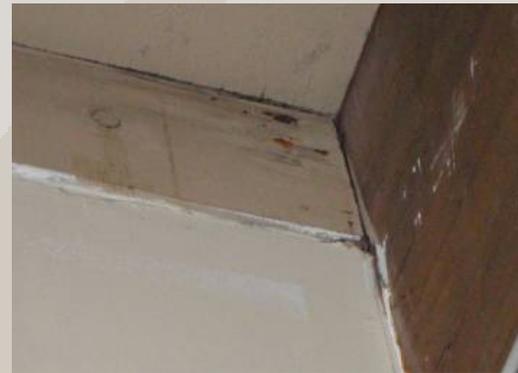
- Essential Facility Category IV
  - Buildings essential for continuous use after major events or disasters.
  - Increased snow / wind / seismic loading requirements.
- Facility does not meet current standard structural building requirements, let alone **essential facility** requirements.

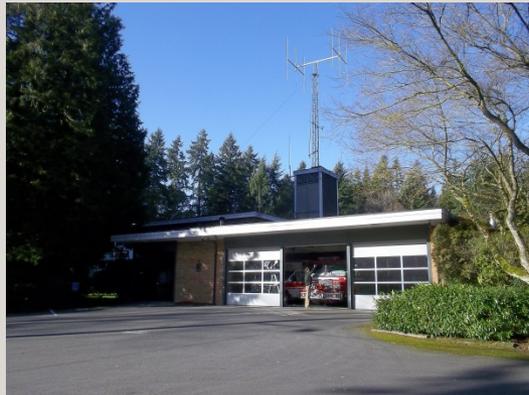
- Essential Facility Category IV
  - Buildings essential for continuous use after major events or disasters.
  - Increased snow / wind / seismic loading requirements.
- Facility does not meet current standard structural building requirements, let alone **essential facility** requirements..

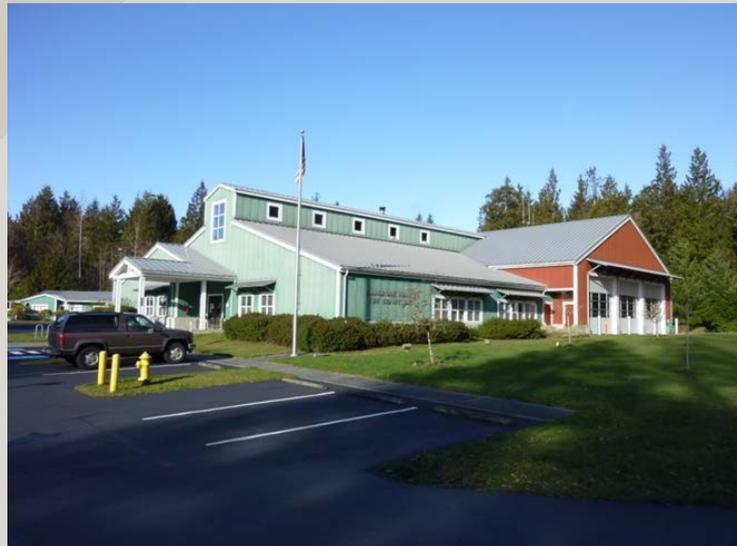
- Essential Facility Category IV
  - Buildings essential for continuous use after major events or disasters.
  - Increased snow / wind / seismic loading requirements.
- Facility needs minor modifications to meet essential facility requirements.
