POLICE

STATION SUMMARY

Police - Existing Facility

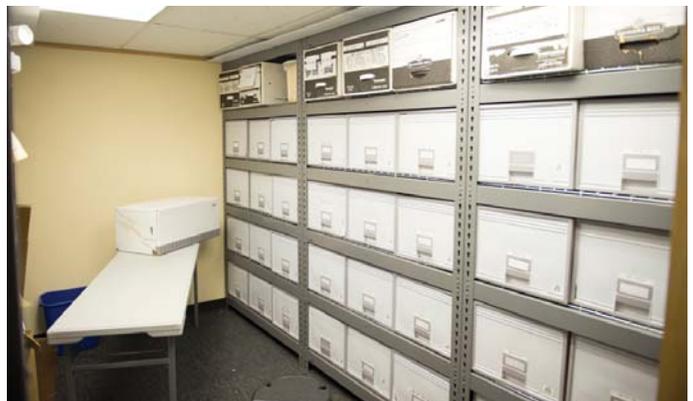
Records Archives

The archives room was the subject of a prior sewage leak, thankfully compromising only one bin of documents. The storage space is currently filled to capacity.

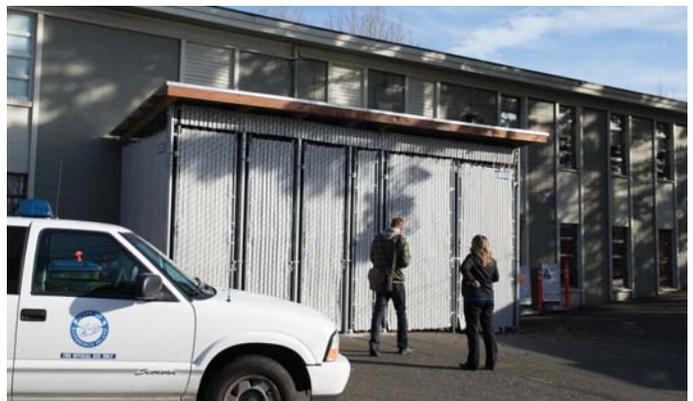
Oversized Storage

To accommodate oversized evidence a storage shed on the south side of the building was recently built using light steel and chain link fence. The evidence lockers are secured with single pad locks and the roof slope forces water to drain against the building. Further, the location of the shed puts the evidence at risk of vehicle collision.
