City of Bainbridge Island

Traffic Report

Focused Traffic Study

December 11, 2013

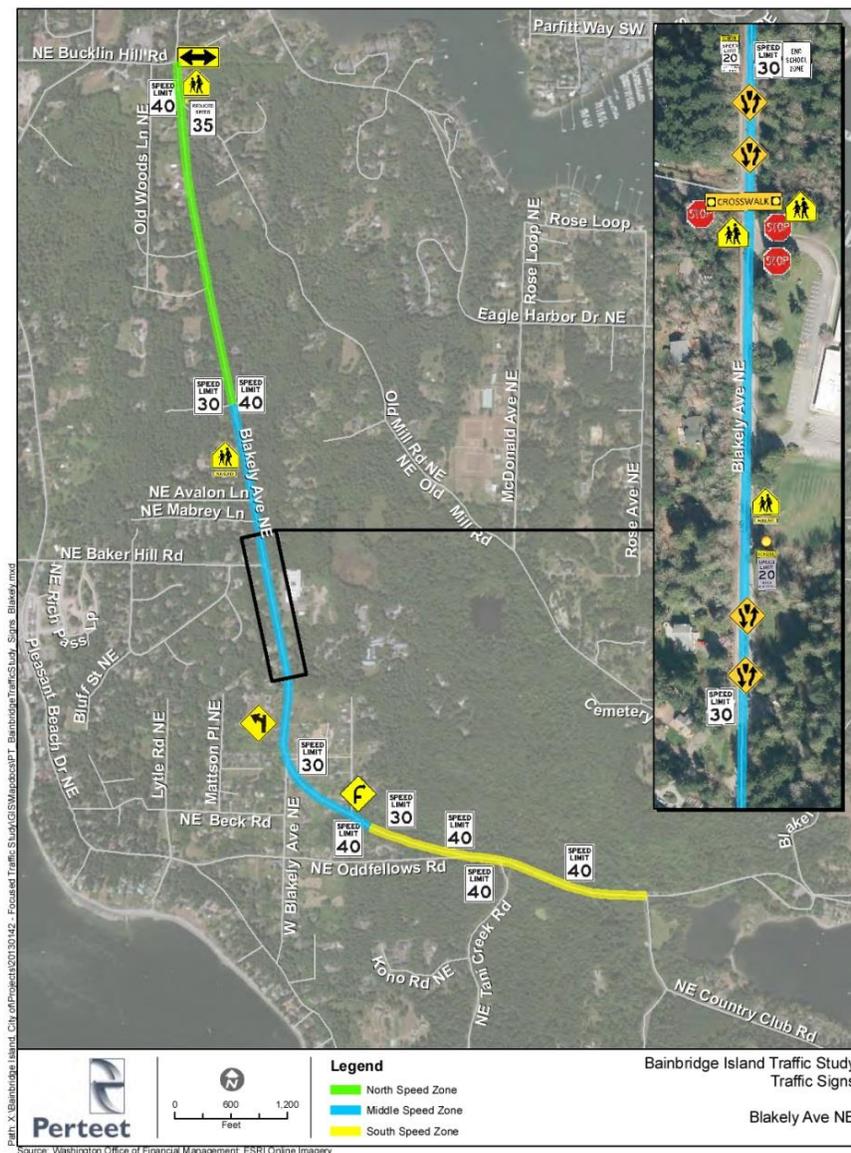
Figure 2-1: Blakely Ave NE corridor map with signing

Blakely Avenue NE is a minor arterial that connects Blakely Harbor to Bucklin Hill Road NE, which leads to the island’s central downtown area. Blakely Avenue NE runs north-south between NE Bucklin Road and W Blakely Ave NE. A horizontal curve in the vicinity of Birkland Rd NE changes the alignment to east-west. Blakely Ave NE has an average daily traffic volume of 3,500 vehicles per day (vpd). The primary objective for this study was to determine the appropriate speed limits for the corridor between NE Country Club Rd and NE Bucklin Hill Rd. Figure 2-1 shows the project limits with the posted regulatory and warning signing along the roadway.

Signing – Some signing in the corridor is not consistent with current Manual on Uniform Traffic Control Devices (MUTCD) standards. When the current W6-1 signs at each end of the median islands near Captain Blakely Elementary School reach the end of their functional life, they should be replaced by standard R4-7 signs³. Type 1 or Type 3 object markers should also be installed for increased visibility⁴. W3-5 or W3-5a signs should be installed in the southbound direction just north of the middle speed zone and in the northbound direction just south of the middle speed zone to inform drivers that they need to reduce their speed by at least 10 mph⁵.

1. Maintain current speed limits and zones.
2. Replace existing W6-1 signs located in the median islands near Captain Blakely Elementary School at the end of their functional life with standard R4-7 signs and Type 1 object markers per the MUTCD.
3. Install reduced speed limit ahead warning signs (W3-5 and W3-5a) for both north and southbound traffic prior to entering the middle speed zone.

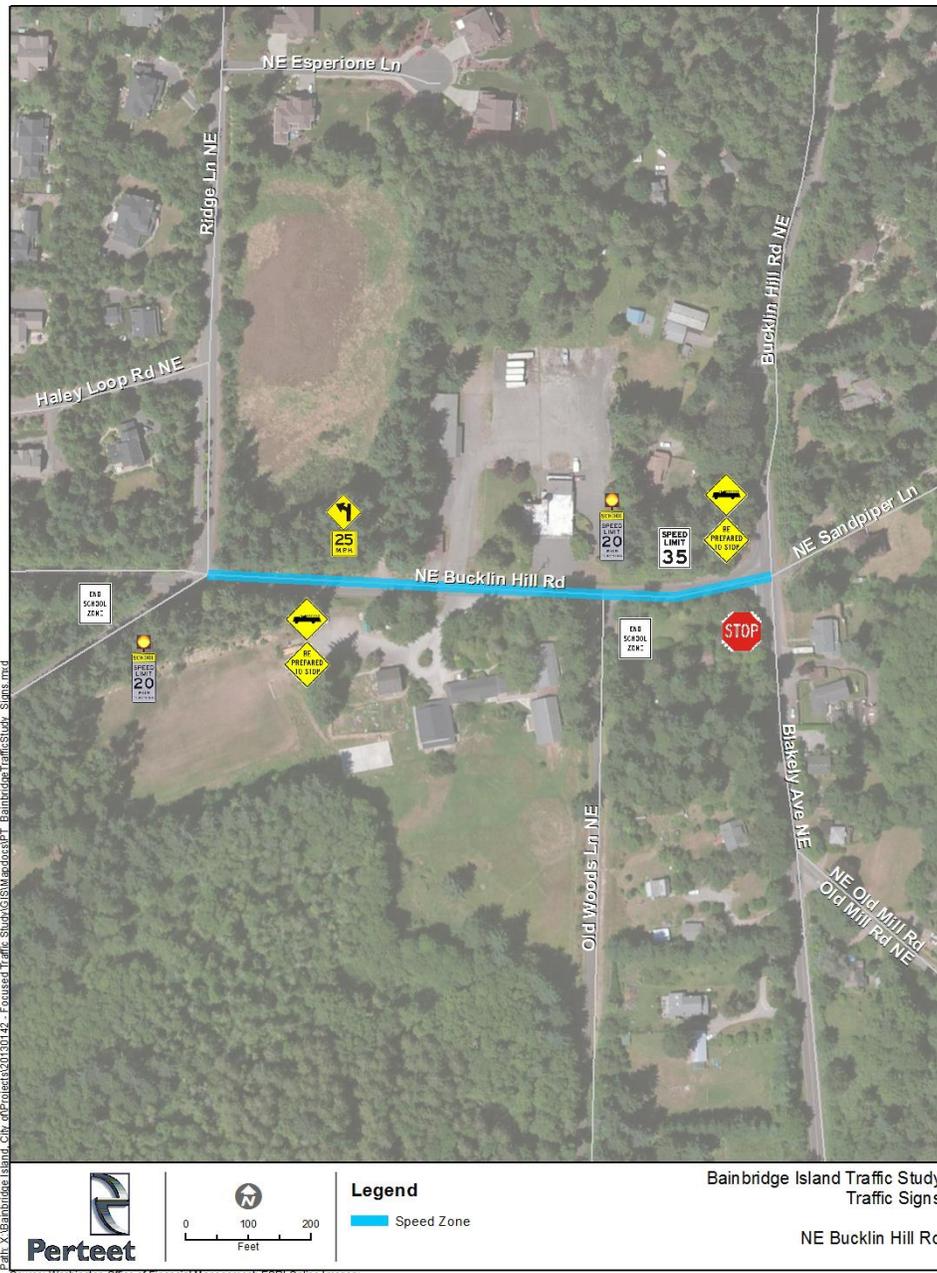
Figure 3-1: NE Bucklin Hill Rd corridor map with signing

NE Bucklin Hill Road is a minor arterial that connects Fletcher Bay Road NE, Lynwood Center Road NE, and Blakely Avenue NE to Eagle Harbor Drive NE. NE Bucklin Hill Rd has an average daily traffic of 2,800 vpd. The primary objective for this study was to determine the appropriate speed limits for the corridor between Lynwood Center Rd NE and Blakely Ave NE. Figure 3-1 shows the project limits with the posted regulatory and warning signing along the roadway.

The corridor has a higher crash rate than the Kitsap County average. FHWA recommends reducing speed limits if crash rates exceed the statewide average. The average crash rate for urban minor arterial state routes in Washington State is 2.57 crashes per million vehicle miles. NE Bucklin Hill Rd does exceed this crash rate. Therefore, it may be warranted to reduce the speed limit due to crash history.

The 85th percentile of 35.8 mph means that the currently posted speed limit of 35 mph is being followed by a majority of the vehicles on the roadway segment. Speed zoning theory best practices recommend that the 85th percentile speed be captured below the posted speed limit in most cases, suggesting that the speed limit should be increased to 40 mph. However, the difference between the posted speed limit and the 85th percentile speed is minimal. With this sample, a lower posted speed limit would increase the percentage of drivers exceeding the posted limit from 15% (at 35 mph) to 53% (at 30 mph).

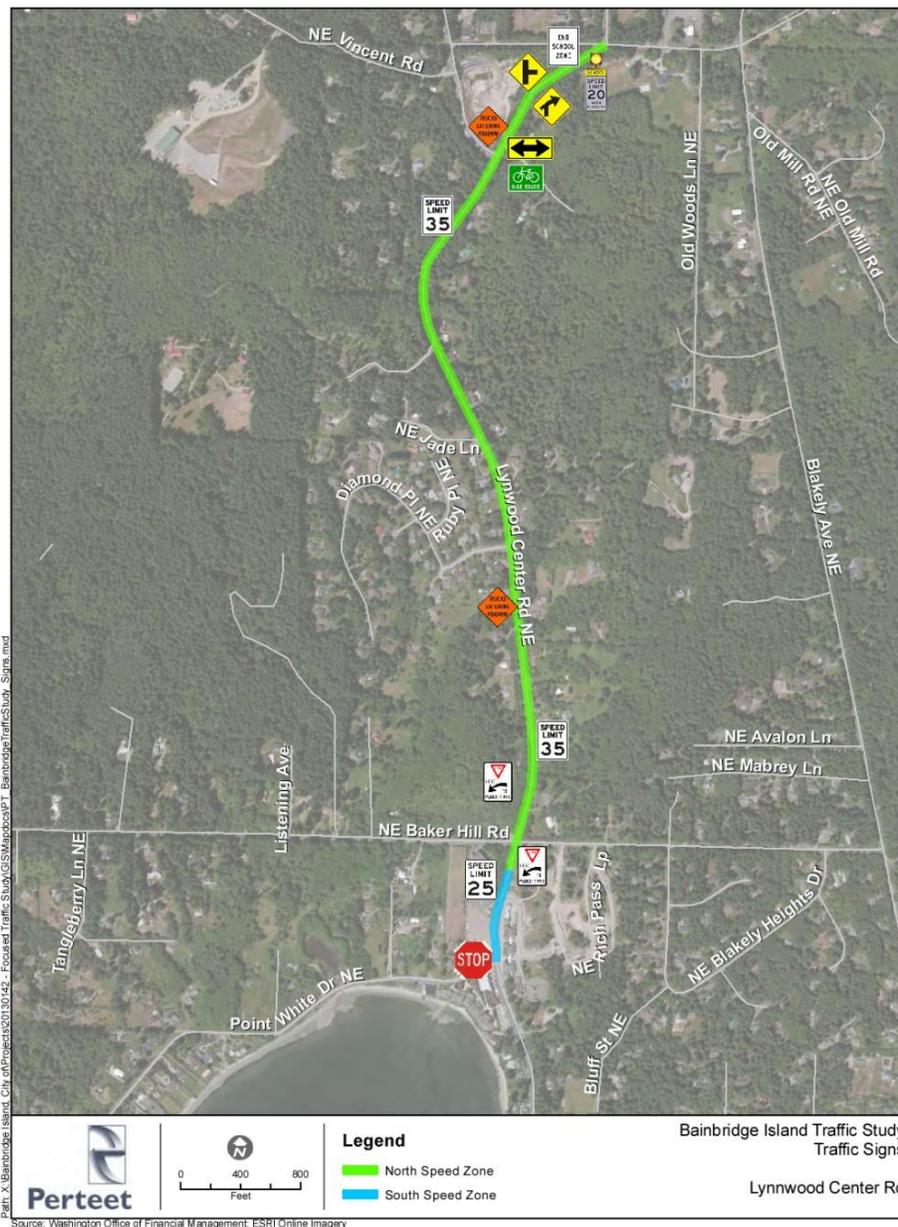
Figure 5-1: Lynwood Center Rd NE corridor map with signing

Lynwood Center Road NE is a minor arterial that connects the middle of Bainbridge Island to the Lynwood Center commercial district. Lynwood Center Rd NE has an average daily traffic volume of 3,850 vpd. The primary objective for this study was to determine the appropriate speed limits for the corridor between Point White Drive NE and NE Bucklin Hill Road. Figure 5-1 shows the project limits with the posted regulatory and warning signing along the roadway.

Speed – Throughout the corridor, the 85th percentile speeds exceed the posted speed limit. In the north speed zone, excessive speeds may be contributing to an increased crash rate because of drivers losing control on the large curve between Fletcher Bay Rd NE and NE Baker Hill Rd, so an increased speed limit is not recommended. Conversely, the north speed zone crash rate is still below county and statewide averages, so a reduced speed is not recommended. To improve compliance in the north speed zone, additional speed limit signs should be installed to inform drivers of the appropriate speed. This treatment should be monitored to gauge if compliance increases. In the commercial area, the current speed limit of 25 mph is consistent with similar areas on the island. The crash history and high pedestrian volumes suggest that the speed is appropriate. To improve compliance as drivers enter the speed zone from the north, a W3-5 (reduced speed limit ahead) sign should be installed before drivers enter the 25-mph speed zone. Northbound traffic through the south zone is adequately controlled by stop signs and crosswalks and slightly higher speeds beyond the commercial area do not pose a safety threat.

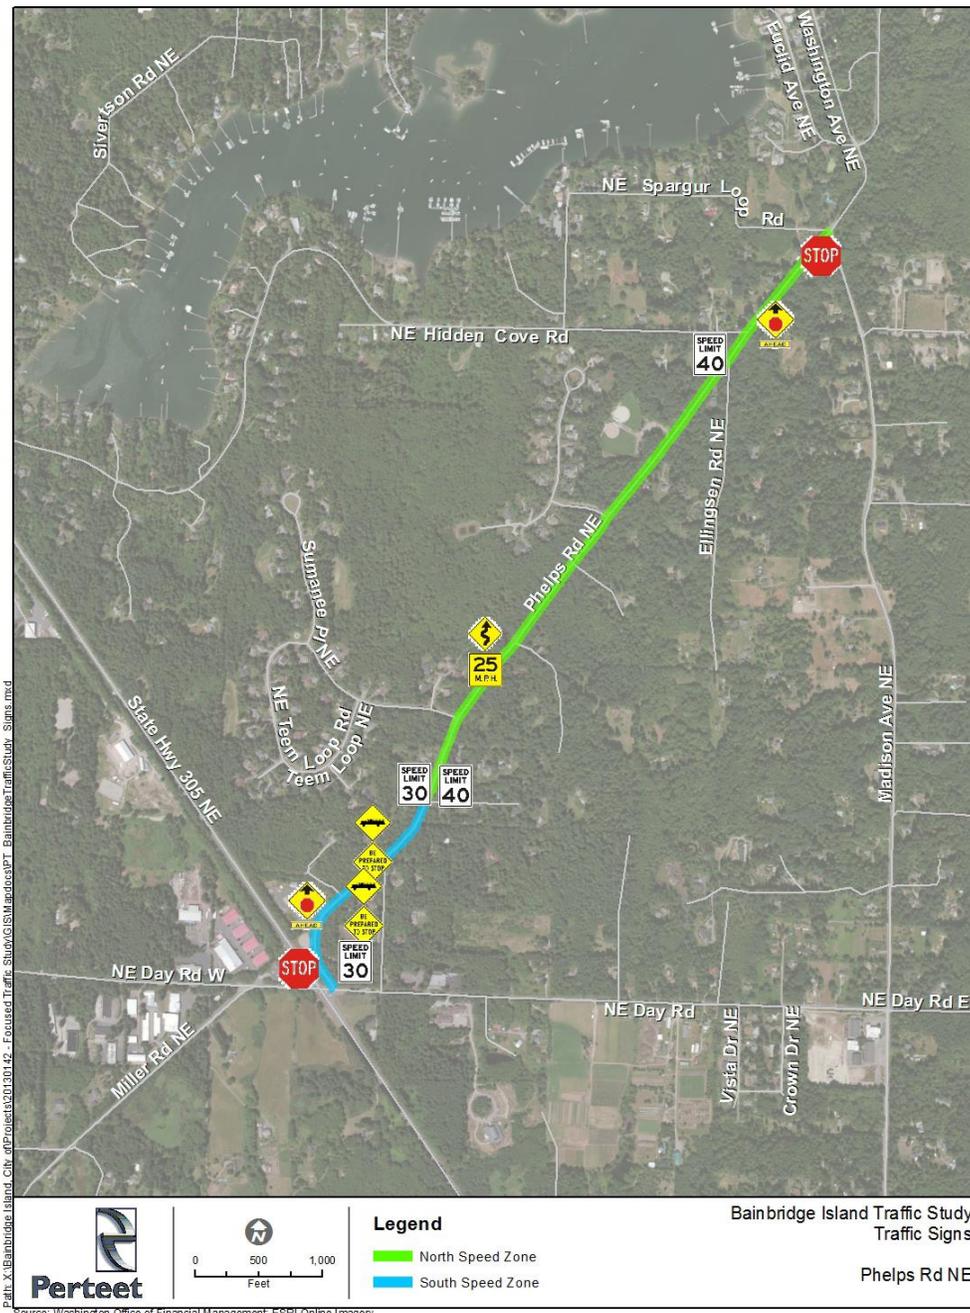
Figure 6-1: Phelps Rd NE corridor map with signing

Phelps Road NE is a minor arterial that connects the Port Madison area to SR-305. Phelps Rd NE has an average daily traffic volume of 1,350 vpd. The primary objective for this study was to determine the appropriate speed limits for the corridor between NE Day Road and Madison Avenue NE. Figure 6-1 shows the project limits with the posted regulatory and warning signing along the roadway.

Curve Signing – The recommended signing for curves on Phelps Rd NE is inconsistent. Within the north speed zone, W1-5 and W13-IP signs inform southbound drivers that they are approaching an S-curve with a recommended speed of 25 mph. While traversing the S-curve, drivers encounter a 30-mph statutory speed limit sign. These signs are not installed for northbound traffic. The large horizontal curve south of the fire station is not marked by any signing and does not have a posted recommended speed. Based on area maps, the curve radius for the horizontal curve appears to be tighter than the radii for the reverse S-curves in the transition speed area, suggesting that a lower advisory speed is appropriate. While this study did not investigate the radii or appropriate recommended travel speeds for each curve, each curve should be evaluated either by using record drawings or a ballbank test to establish the maximum safe travel speed and to determine the appropriate signing that should be installed.

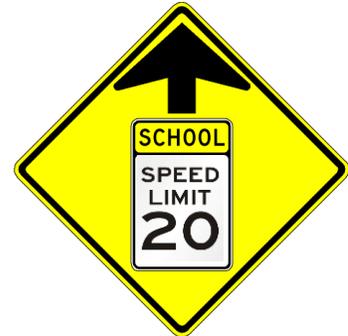
S4-5

Speed Zones – The current speed limits for this corridor are not consistent: southbound is posted at 40 mph, while northbound is posted at 40 mph, 30 mph, and 20 mph (during school zone hours only). Speed zones should be balanced whenever possible to improve operations and meet driver expectations. Because of a minimal crash history and no apparent geometric restrictions, the northbound speed limit should be raised to 40 mph in all portions of the corridor that are not currently within a school zone. The existing 30-mph statutory speed limit sign should be removed and replaced with a reduced school speed limit ahead (S4-5) sign to notify drivers that they are approaching a school zone.

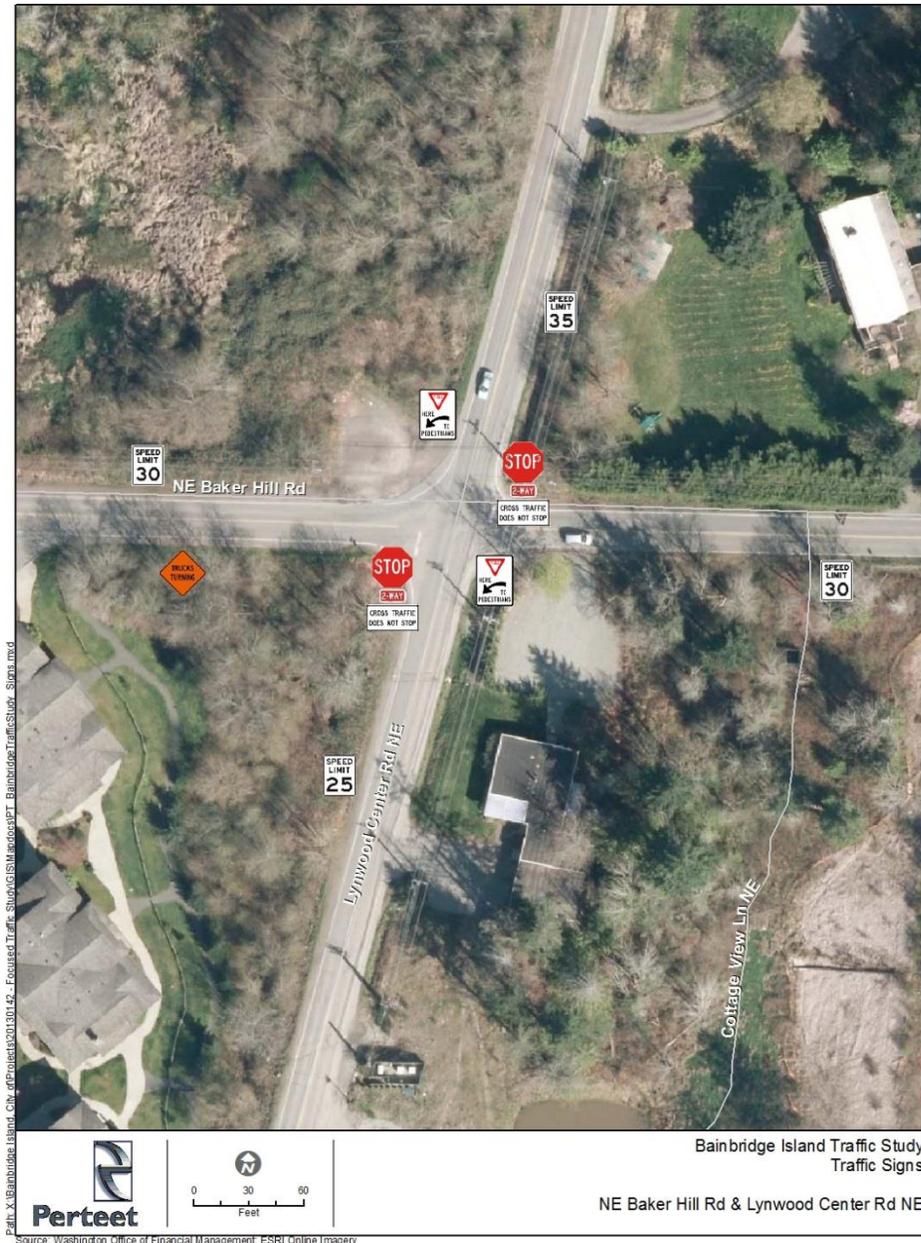
Figure 10-1: Signing at Lynwood Center Rd NE & NE Baker Hill Rd

Lynwood Center Road NE intersects NE Baker Hill Road less than 500 feet north of the Lynwood Center urban area. Currently, Lynwood Center Rd NE near this intersection has an average daily traffic volume of 3,850 vpd. NE Baker Hill Rd has an average daily traffic volume of 1,700 vpd. The primary objective for this intersection was to determine if Lynwood Center Rd NE should be stop-controlled, creating all-way stop control at the intersection. Figure 10-1 shows the intersection with the posted regulatory and warning signing.

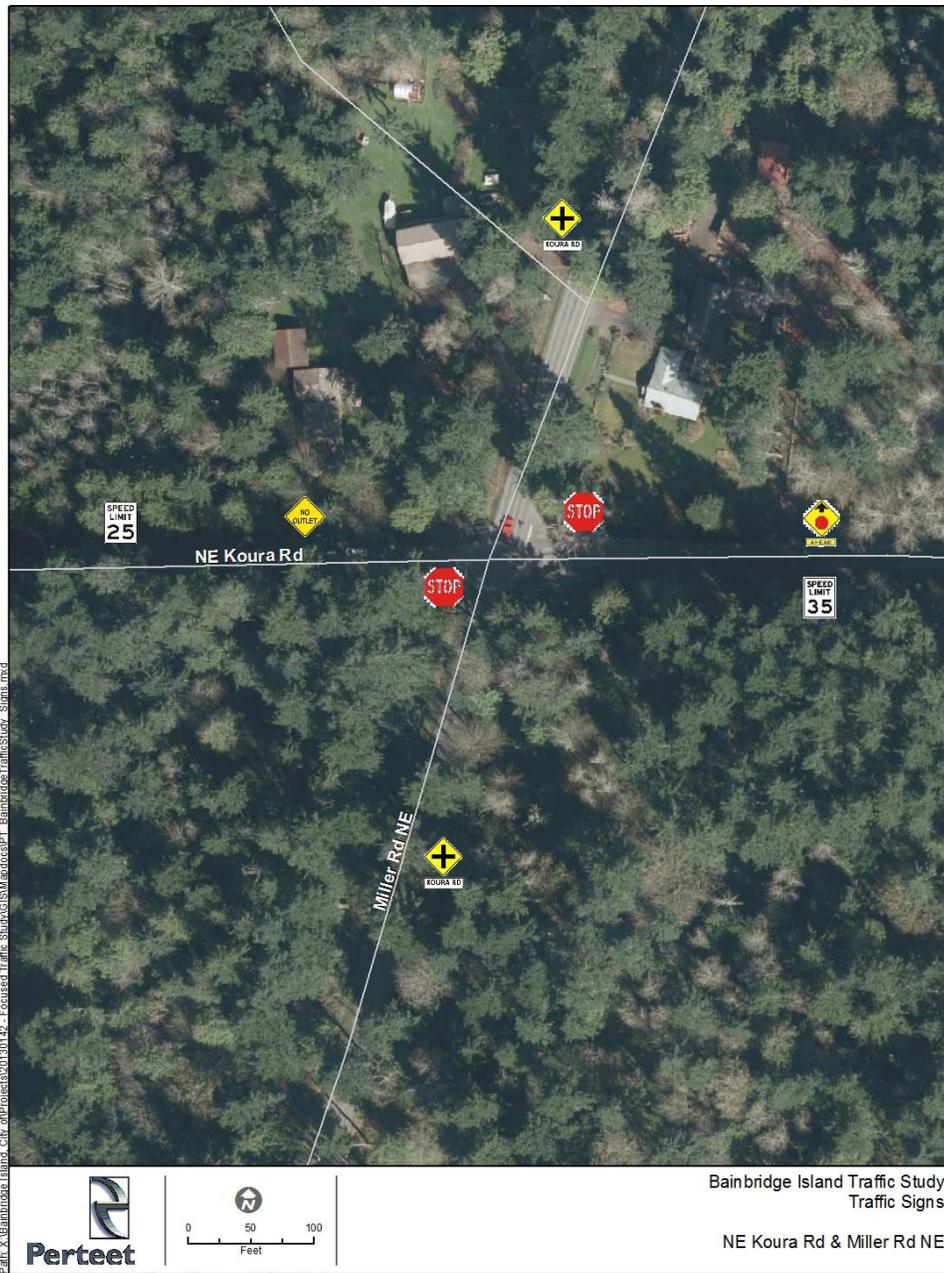
Figure 11-1: Signing at Miller Rd NE & NE Koura Rd

Miller Road NE intersects NE Koura Road 1.4 miles west of SR-305. Currently, Miller Rd NE near this intersection has an average daily traffic volume of 4,800 vpd. NE Koura Rd has an average daily traffic volume of 1,625 vpd. The primary objective for this intersection was to determine if Miller Rd NE should be stop-controlled, creating all-way stop control at the intersection. Figure 11-1 shows the intersection with the posted regulatory and warning signing.

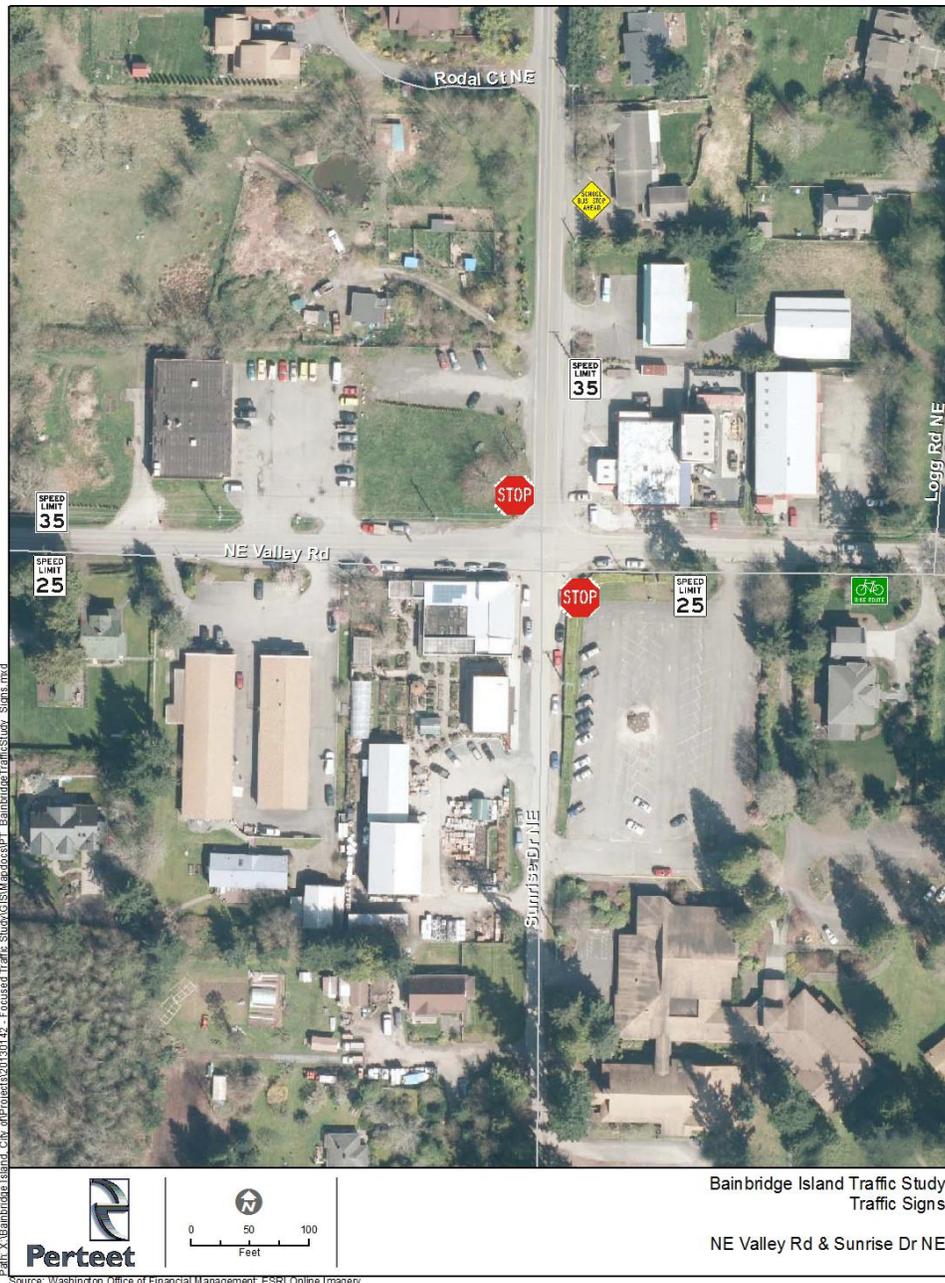
Figure 12-1: Signing at NE Valley Rd & Sunrise Dr NE

NE Valley Rd intersects Sunrise Dr NE at the Rolling Bay commercial area. Currently, NE Valley Rd near this intersection has an average daily traffic volume of 2,800 vpd. Sunrise Dr NE has an average daily traffic volume of 1,500 vpd. The primary objective for this intersection was to determine if NE Valley Rd should be stop-controlled, creating all-way stop control. Figure 12-1 shows the intersection with the posted regulatory and warning signing.
